FEMA PAL Response Report

SANTA CLARA RIVER LEVEE (SCR-1)

HIGHWAY 101 TO SATICOY

FEMA ID No. 18

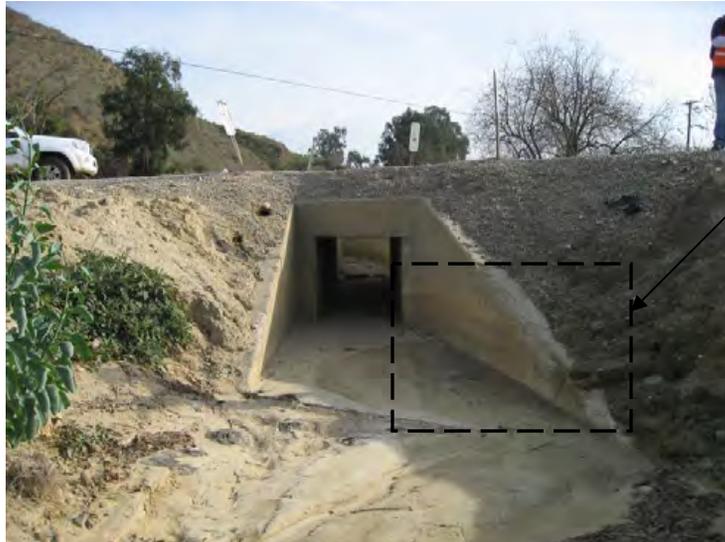
Santa Clara River Levee, From Hwy 101 to Saticoy. (Photo No. M1) –
Damaged concrete on Side Drain 1A headwall with rebar exposed

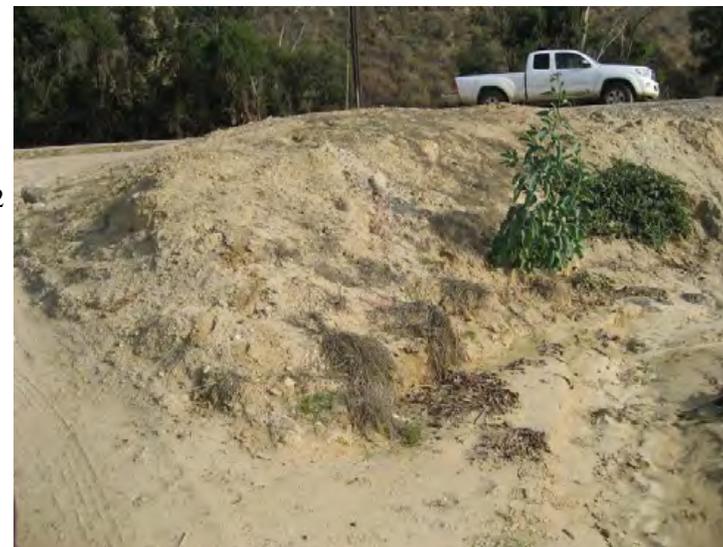
Santa Clara River Levee, From Hwy 101 to Saticoy. (Photo No. M3) –
Sediment spoils, upstream end of levee (riverward side)

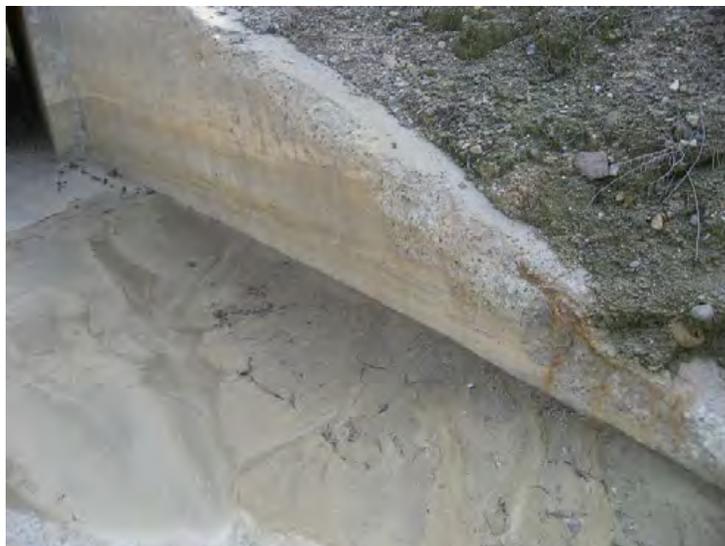
Santa Clara River Levee, From Hwy 101 to Saticoy. (Photo No. M2) –
Detail of damaged concrete headwall & exposed rebar (riverward side)

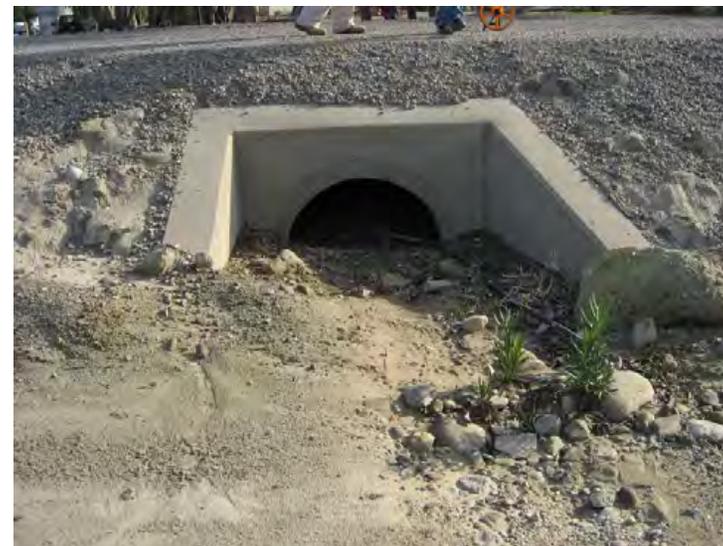
Santa Clara River Levee, From Hwy 101 to Saticoy. (Photo No. M4) –
Sediment deposition in Side Drain No. 1, 42" RCP outlet (riverward side)

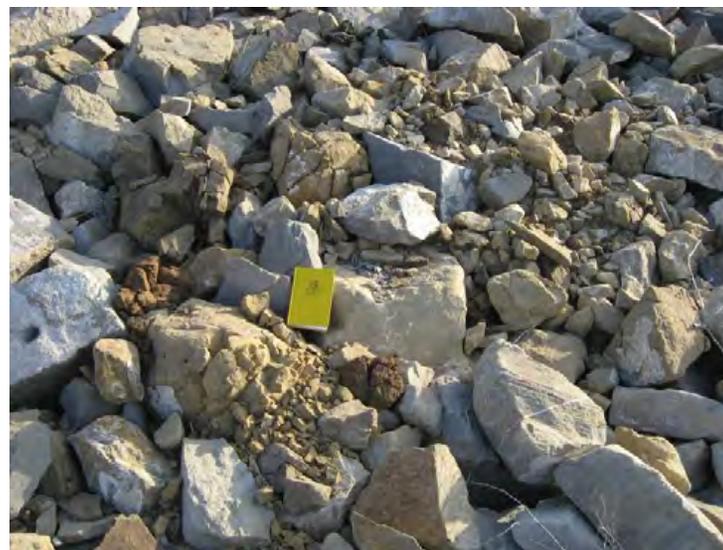
Santa Clara River Levee, From Hwy 101 to Saticoy. (Photo No. M8) –
Broken stone revetment (riverward side)

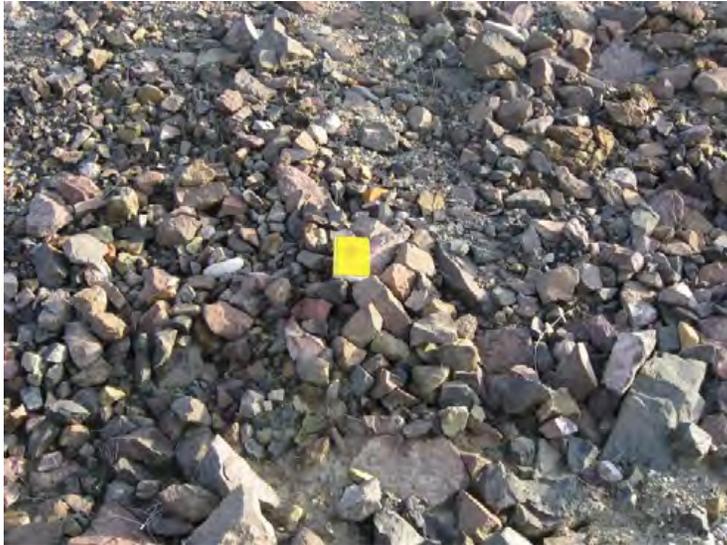
Santa Clara River Levee, From Hwy 101 to Saticoy. (Photo No. M9) –
Broken stone revetment (riverward side)

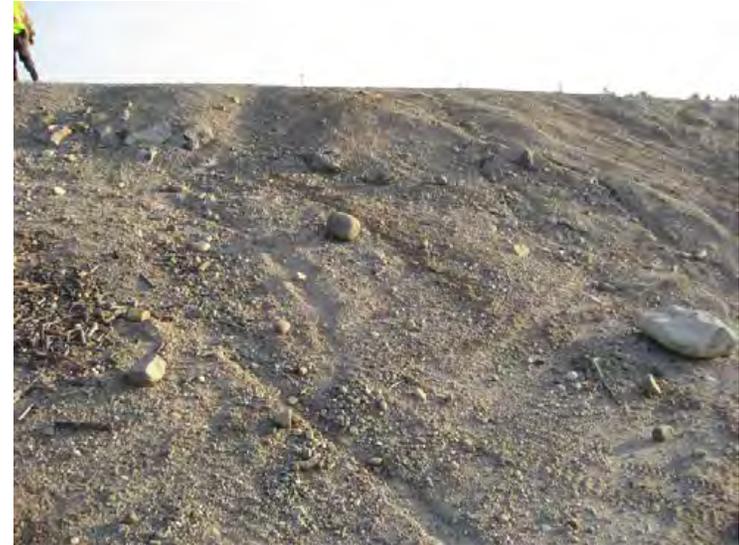
Santa Clara River Levee, From Hwy 101 to Saticoy. (Photo No. M11) –
Erosion of levee embankment (riverward side)

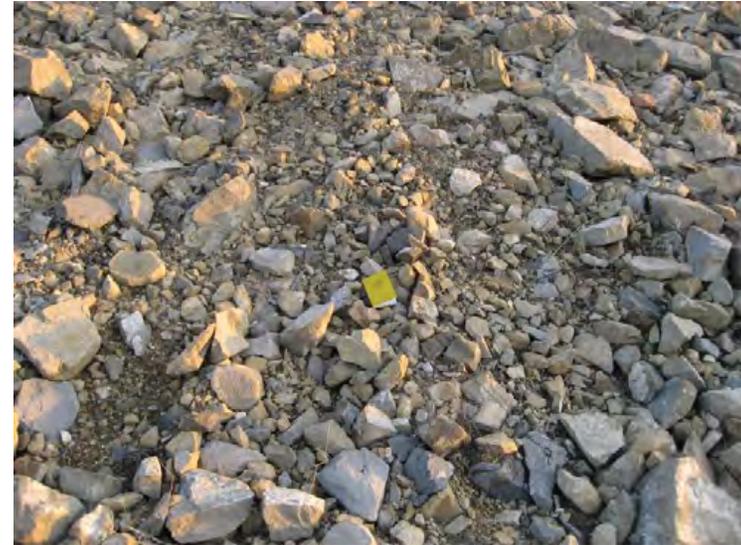
Santa Clara River Levee, From Hwy 101 to Saticoy. (Photo No. M19) –
Broken stone revetment (riverward side)

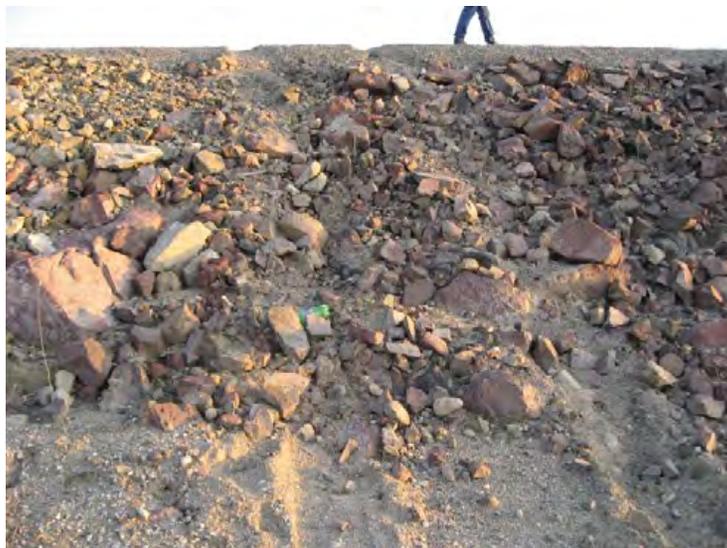
Santa Clara River Levee, From Hwy 101 to Saticoy. (Photo No. M18) –
Levee embankment erosion caused by vehicles (riverward side)

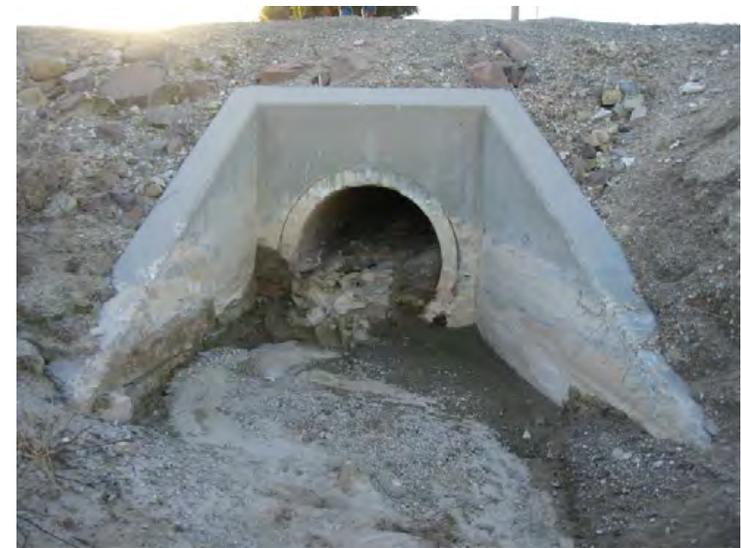
Santa Clara River Levee, From Hwy 101 to Saticoy. (Photo No. M20) –
Sediment deposition in Side Drain No. 3, 48" RCP outlet (riverward side)

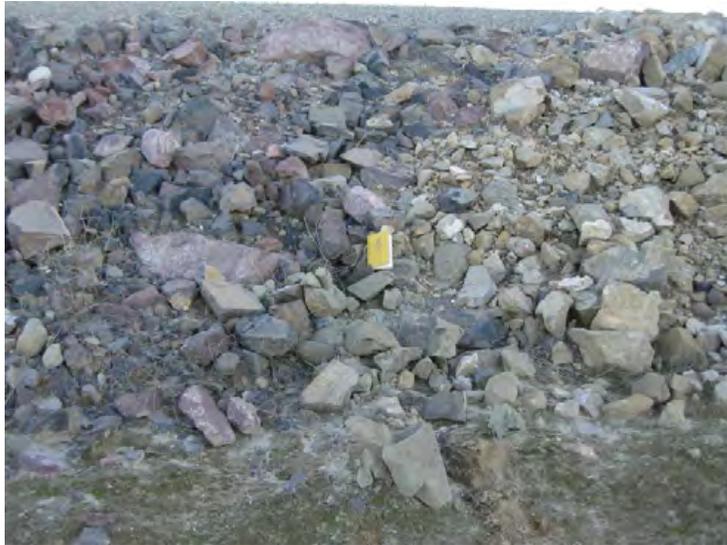
Santa Clara River Levee, From Hwy 101 to Saticoy. (Photo No. M21) –
Broken stone revetment (riverward side)

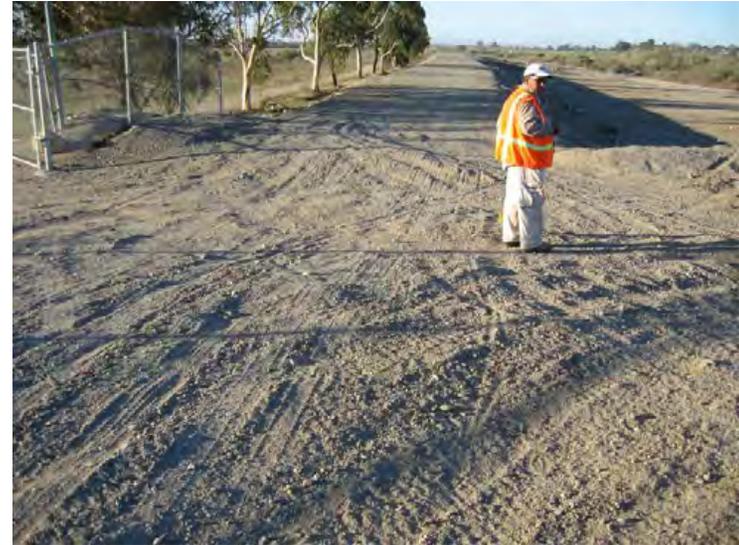
Santa Clara River Levee, From Hwy 101 to Saticoy. (Photo No. M23) –
Erosion on top of levee caused by vehicles, looking d/s (riverward side)

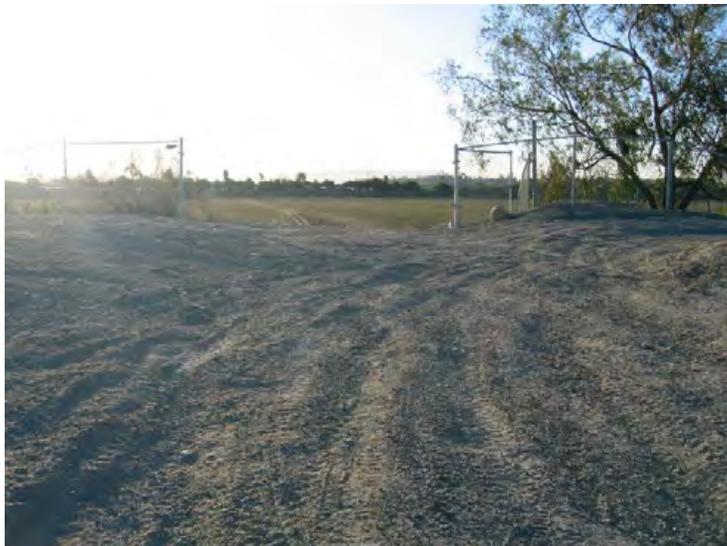
Santa Clara River Levee, From Hwy 101 to Saticoy. (Photo No. M22) –
Erosion on top of levee caused by vehicles (riverward side)

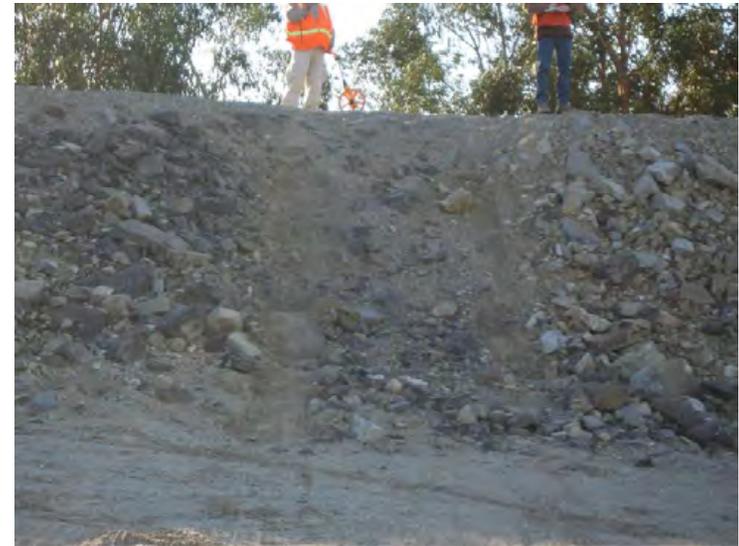
Santa Clara River Levee, From Hwy 101 to Saticoy. (Photo No. M24) –
Levee embankment erosion caused by vehicles (riverward side)

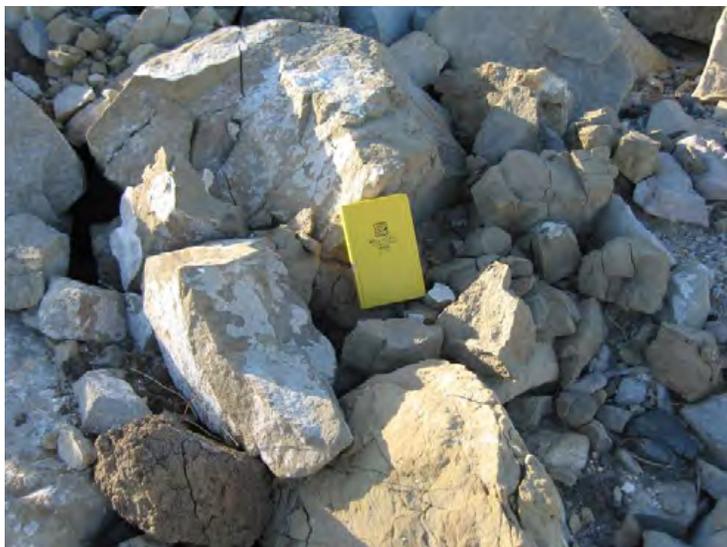
Santa Clara River Levee, From Hwy 101 to Saticoy. (Photo No. M25) –
Broken stone revetment (riverward side)

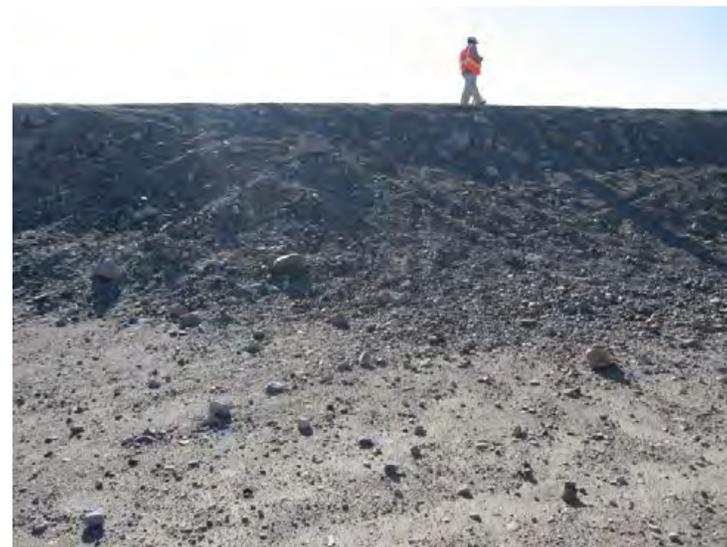
Santa Clara River Levee, From Hwy 101 to Saticoy. (Photo No. M27) –
Unauthorized ramp on levee (riverward side)

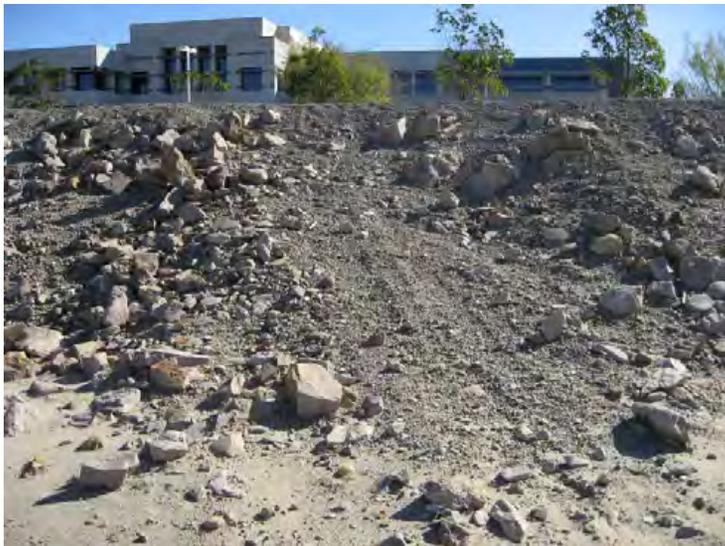
Santa Clara River Levee, From Hwy 101 to Saticoy. (Photo No. M38) – Unauthorized ramp with missing levee embankment protection (riverward)

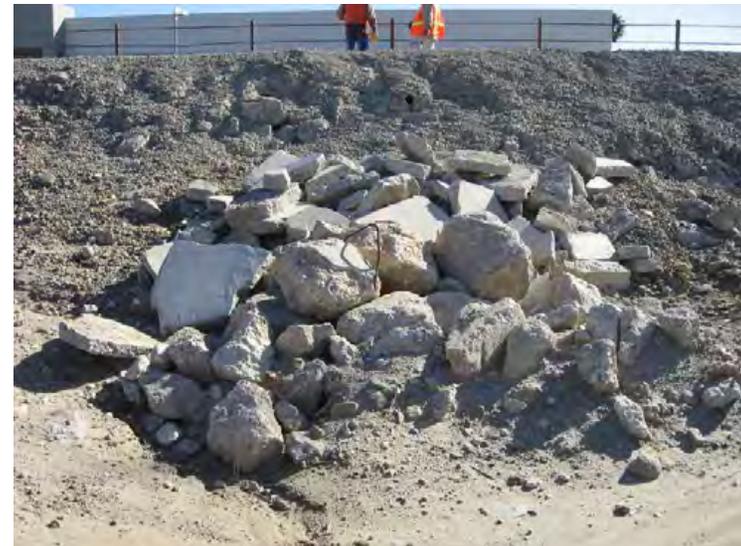
Santa Clara River Levee, From Hwy 101 to Saticoy. (Photo No. M40) – Dumped concrete debris at levee toe (riverward side)

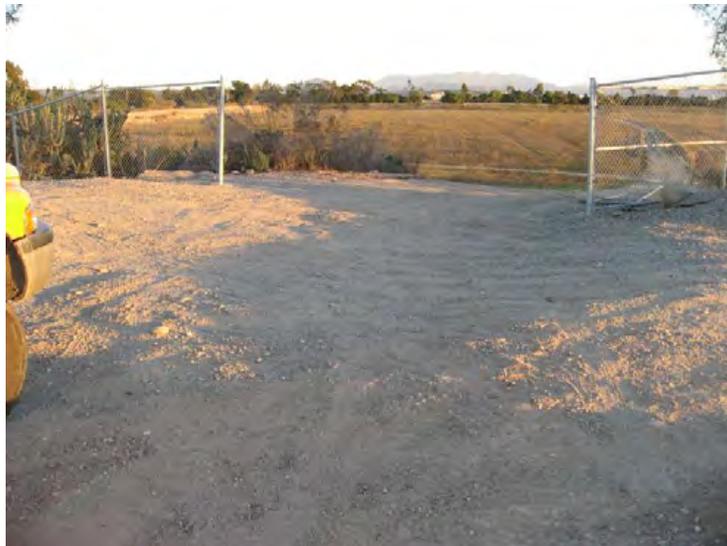
Santa Clara River Levee, From Hwy 101 to Saticoy, (Photo No. M66) –
Erosion on top of levee caused by vehicles, looking S/E (landward side)

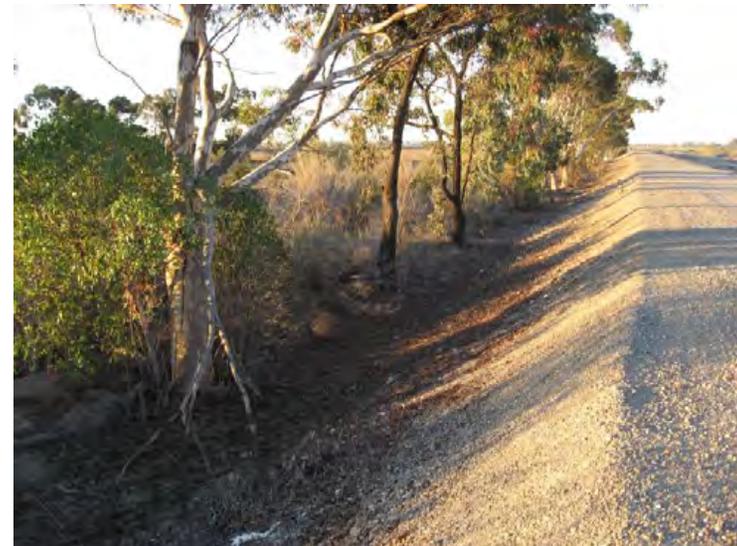
Santa Clara River Levee, From Hwy 101 to Saticoy, (Photo No. M68) –
Vegetation within 15-feet of levee toe, looking d/s (landward side)

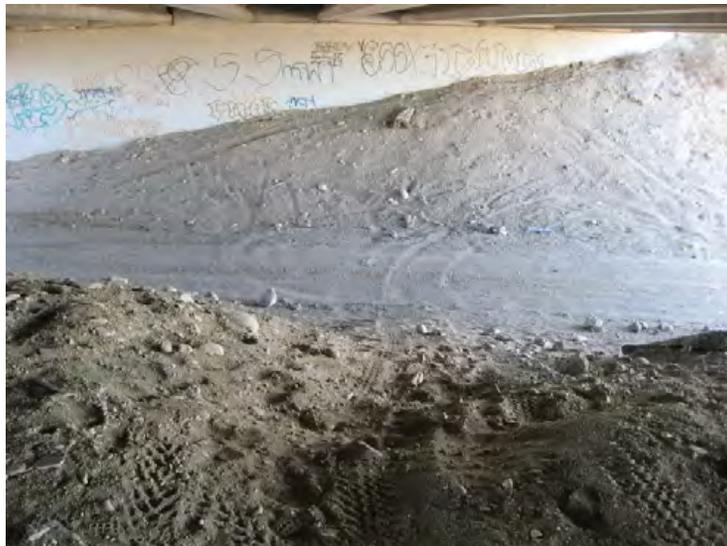
**Santa Clara River Levee, From Hwy 101 to Saticoy, (Photo No. M74) –
Erosion caused by vehicles under L.A. Ave. Bridge (landward side)**

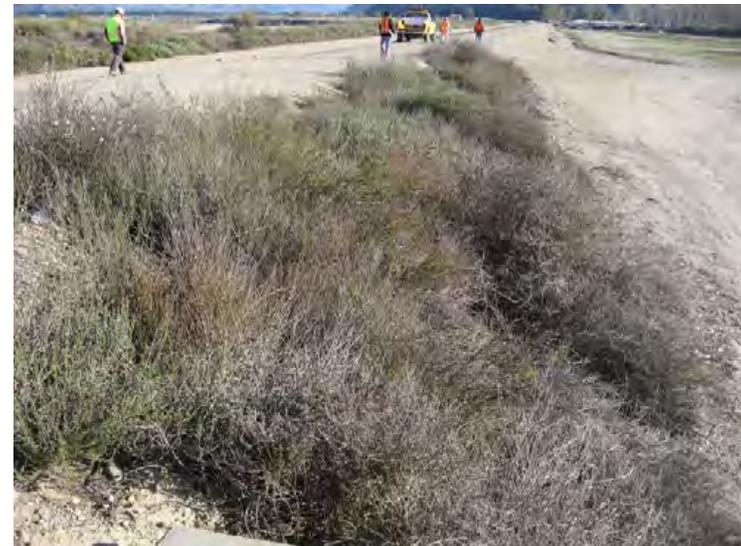
**Santa Clara River Levee, From Hwy 101 to Saticoy, (Photo No. M76) –
Vegetation within 15-feet of levee toe, looking downstream (landward side)**

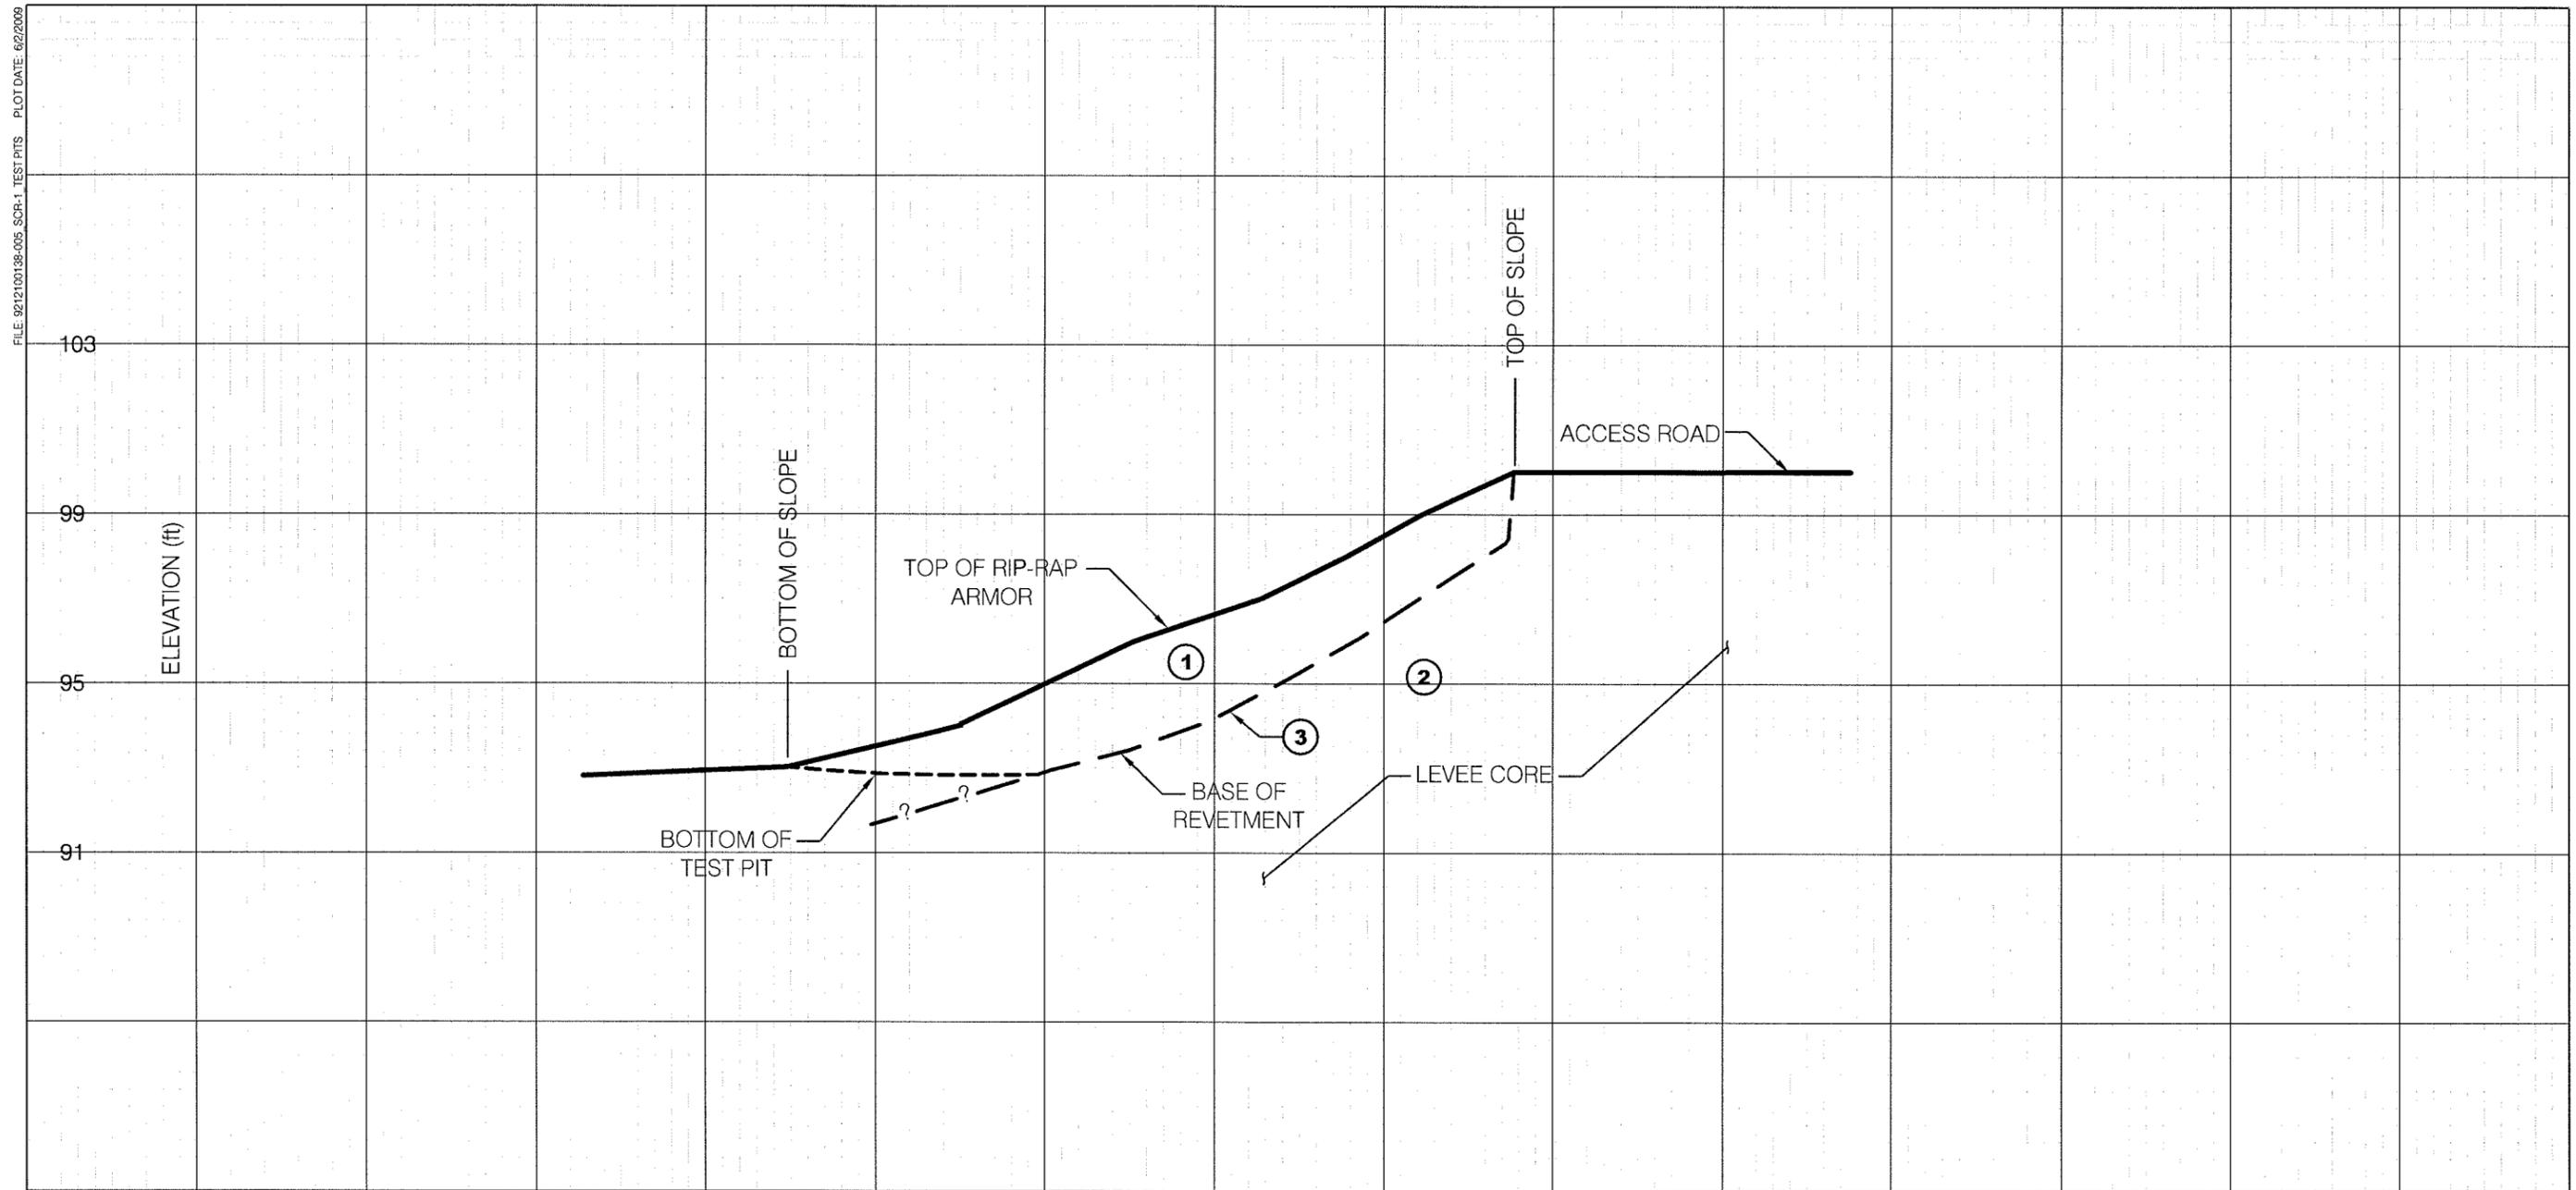
SCR-1-TP1

- ① Rip-rap is typically between 19" and 4" infilled with brown SILTY SAND. Rip-rap is composed primarily of brown and gray stone, subangular to subrounded with scattered subrounded granitic cobbles.
- ② Levee material is dark brown SILTY SAND with GRAVEL
- ③ No filter material observed below rip-rap revetment stone

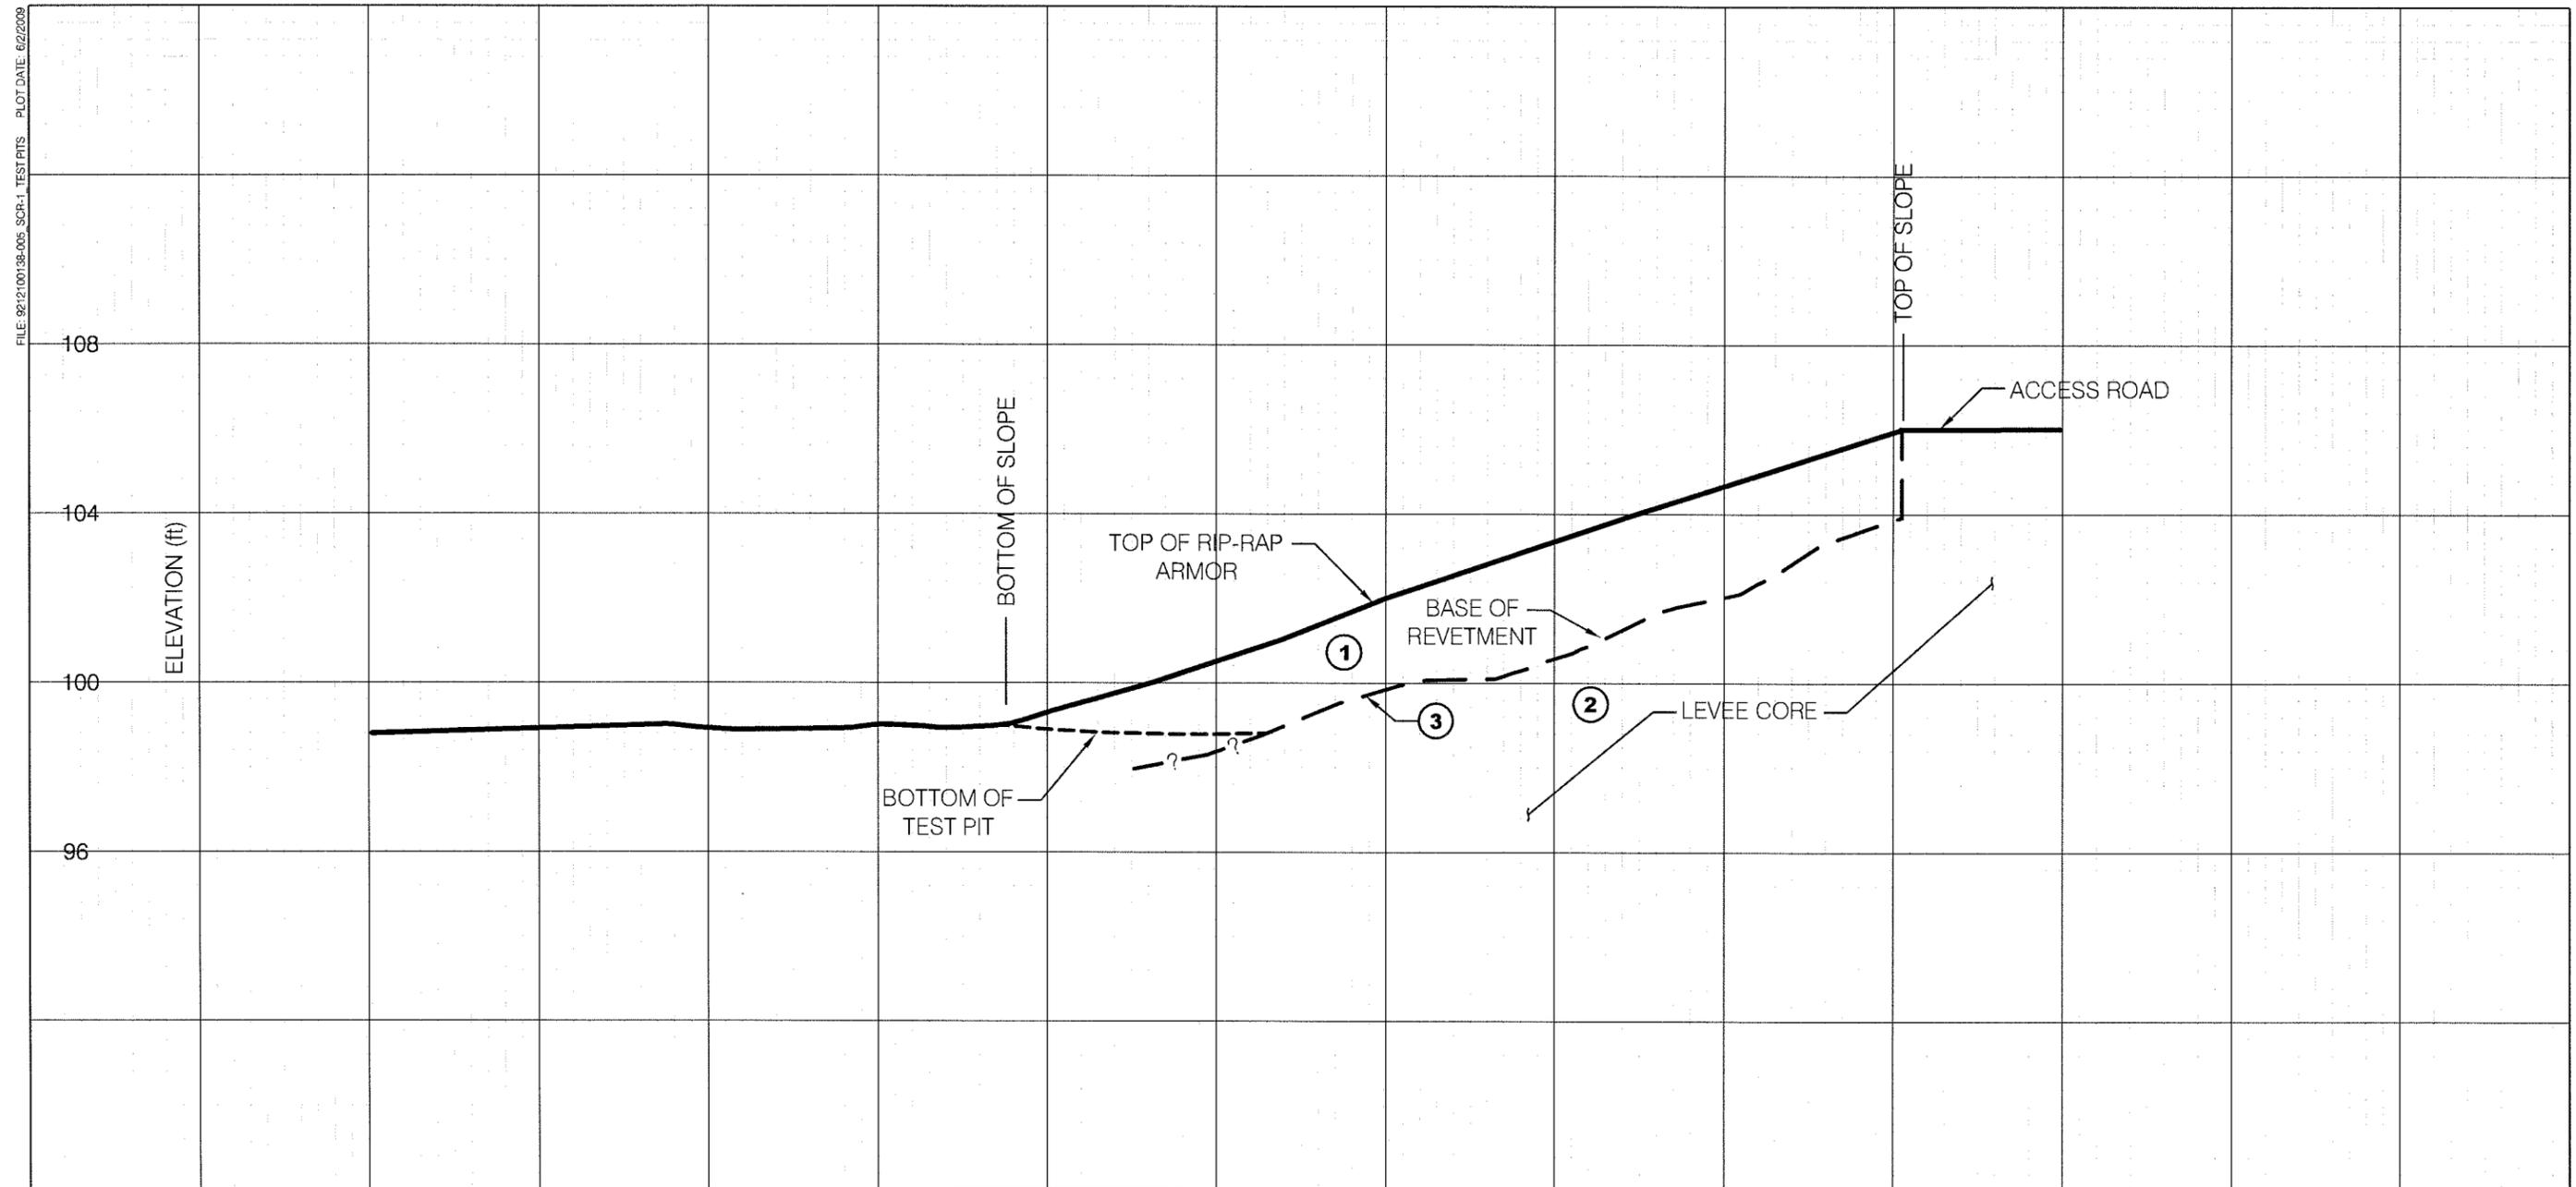
- ① Rip-rap is typically between 8" or less with some larger; several large +24" boulders, infilled with brown SILTY SAND. Rip-rap is composed primarily of brown and gray sandstone, scattered, subangular (less than 2%) subrounded, granitic COBBLES.
- ② Levee material is dark brown SILTY SAND.
- ③ No filter material observed below rip-rap revetment.
(No samples taken at this location)

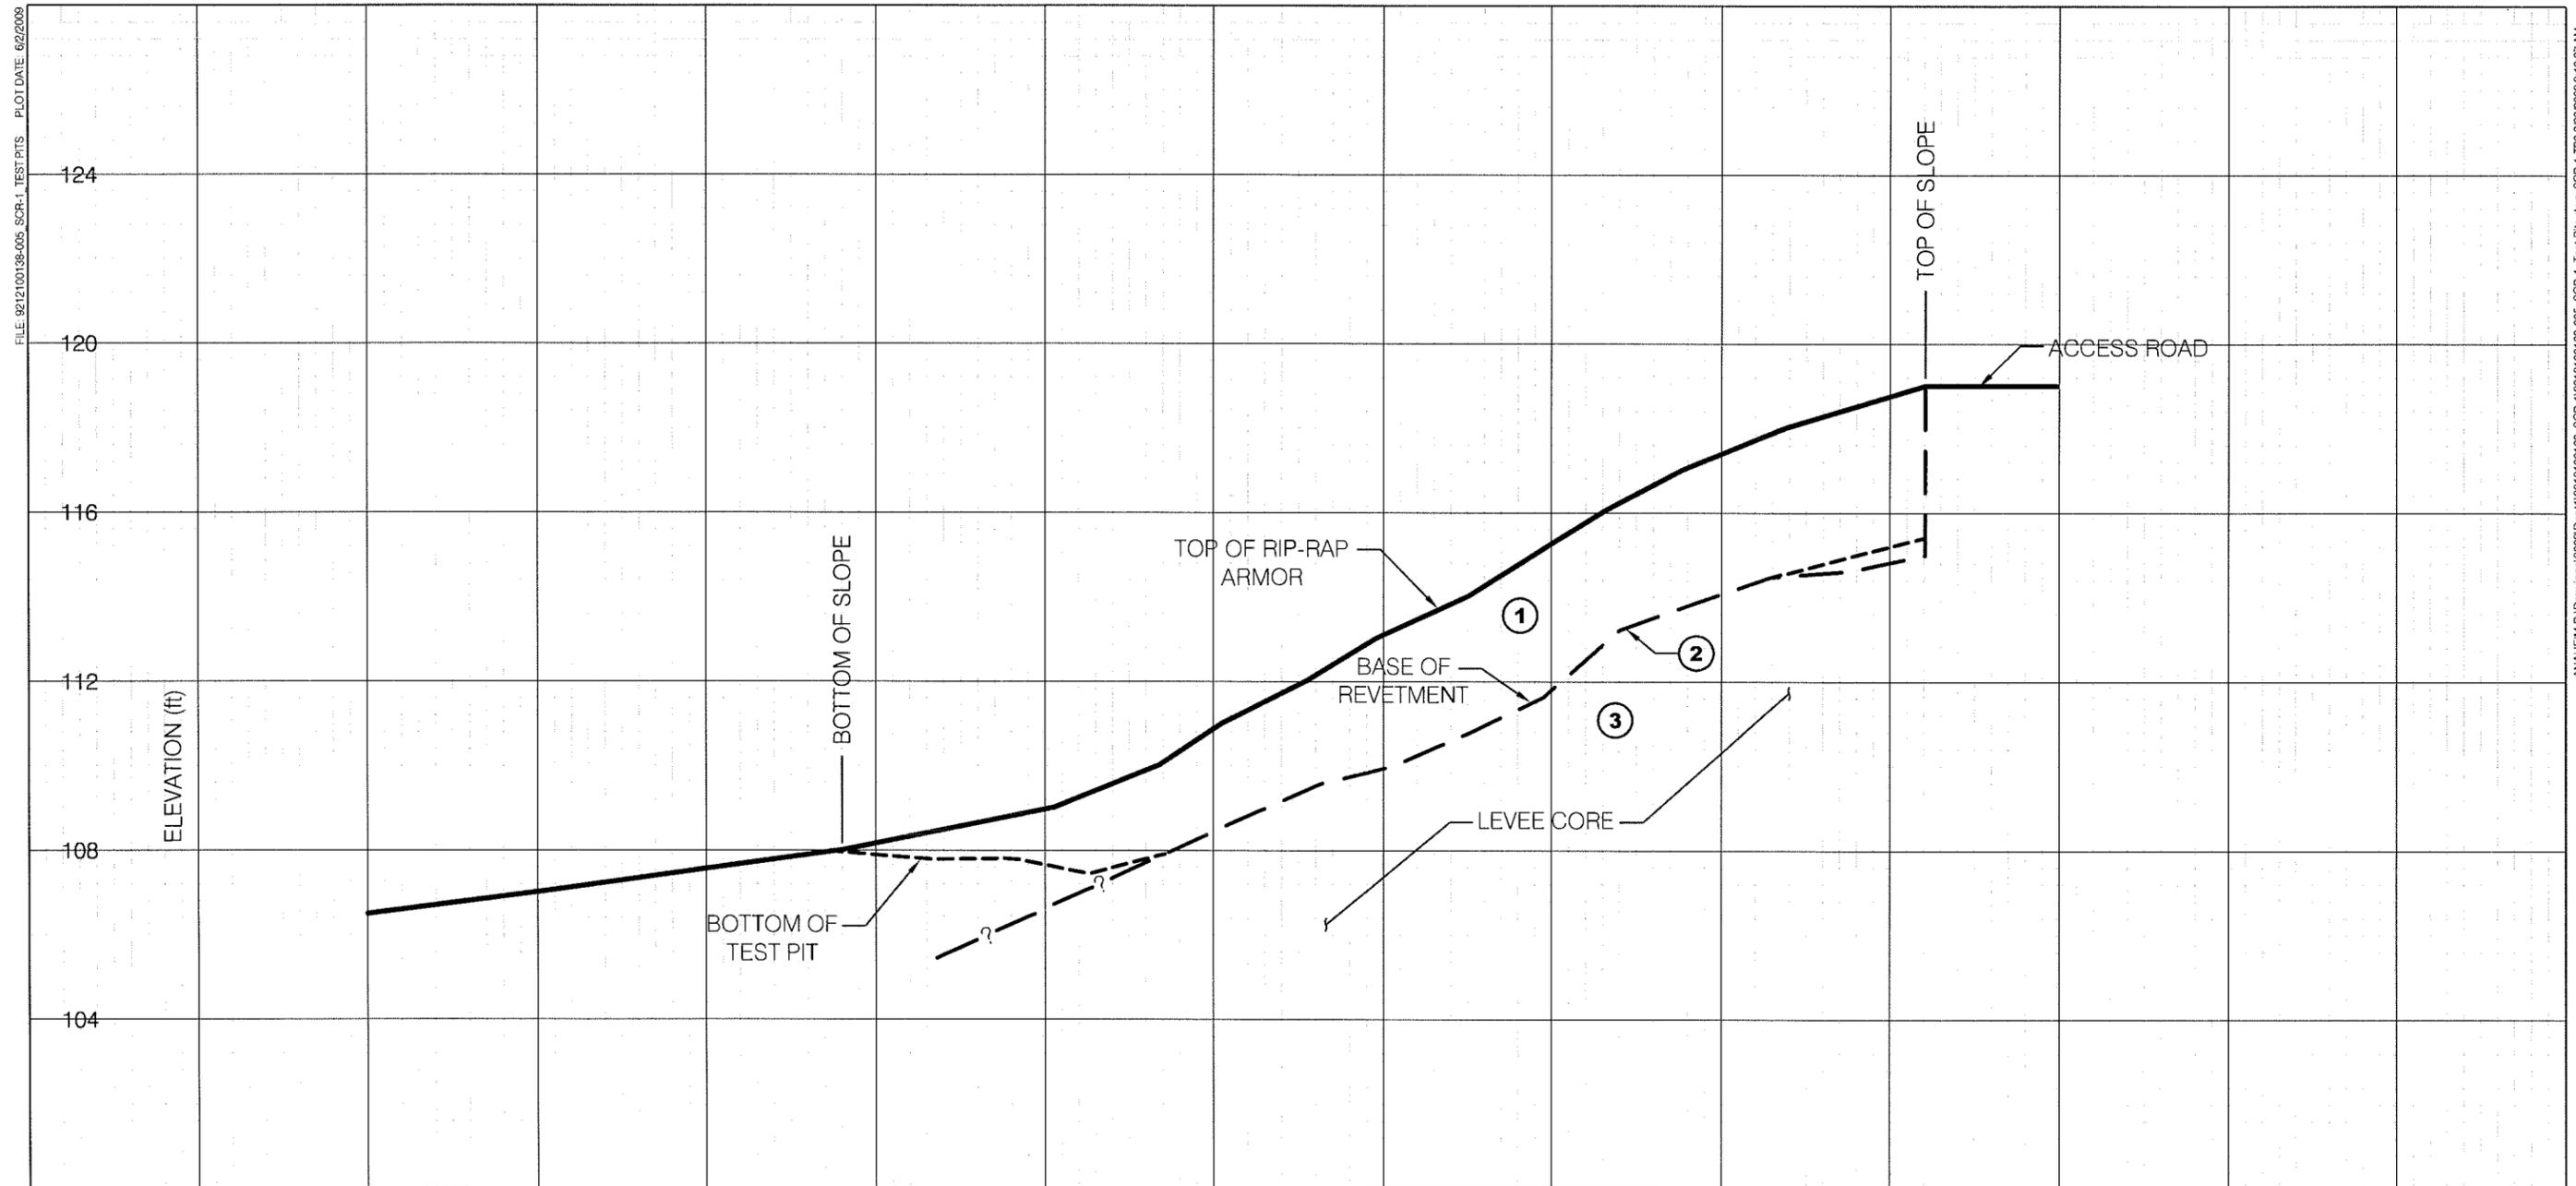
- ① Rip-rap is predominantly brown and gray SANDSTONE 8" to 4" in diameter, angular to subrounded, minor amounts of rhyolite, 5% to 10% SAND (very little sand or fines).
- ② Levee material is light brown coarse grained SAND with GRAVEL.
- ③ No filter material observed below rip-rap revetment.
