Ventura River Levee (VR-1) Rehabilitation

California Environmental Quality Act (CEQA)
Public Scoping Presentation

Ventura County Public Works Agency – Watershed Protection

September 2020

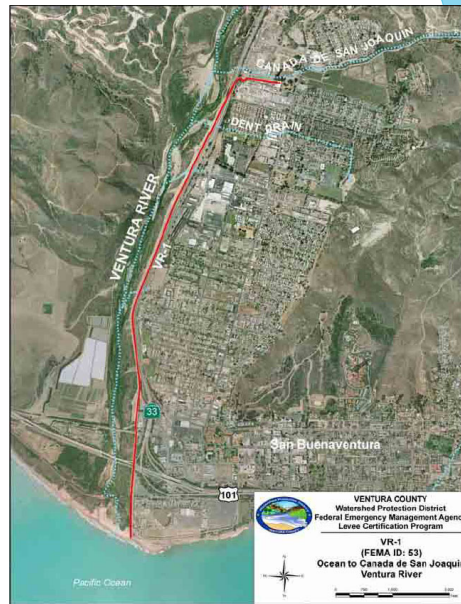
Location of the Ventura River VR-1 System

- ▶ 2.65-mile-long levee system
- ▶ Extends along eastern bank of the Ventura River from the Pacific Ocean to the confluence with the Cañada de San Joaquin
- ▶ Extends 1000 ft east along the southern bank of the Cañada de San Joaquin

This presentation will discuss a proposed project concerning the Ventura River levee. The Ventura River levee is located within the City of San Buenaventura along the east bank of the Ventura River. The levee is approximately 2.65 miles long and begins at the Pacific Ocean and continues north to the confluence with Cañada de San Joaquin. The levee was originally constructed by the U.S. Army Corps of Engineers in 1948 and has been operated and maintained by Watershed Protection since 1963. The levee protects commercial, residential, and industrial properties in low-lying areas within the floodplain of the Ventura River Watershed.

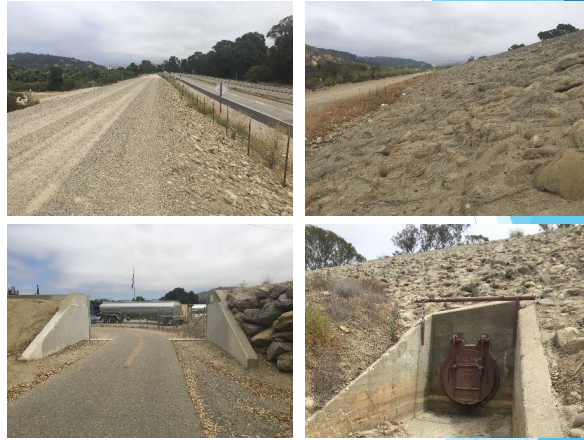
VR-1 Levee System Components

- ▶ Embankment
- ▶ Side-slope protection (riverside) consisting of loose or grouted riprap, concrete floodwalls
- ▶ Side-drainage penetrations
- ▶ Stop-log structure at a bike trail crossing

The embankment is made of earthen material and is above ground, generally with rock covered side slopes along the riverside and also on the land side of the levee. This can be seen on the top left photo.

The top right photos shows the riverside slope which consists of rock armor protection designed to protect the levee from erosive river flows. This slope protection extends beneath the river bottom, with what is known as toe-down.

As can be seen on the lower right photo, the levee system also consists of side drainage or interior drainage penetrations, such as a pipe, that directs flows into the river. These side drainage penetrations have a cover to prevent water from backing up into the pipe from the river side.

The levee also has a stop-log structure at the bike trail crossing at the upstream end of the levee that can be installed during large storm events as shown on the lower left photo. Prior to a flood event, boards are placed between the two concrete wing walls to block the flow of water.

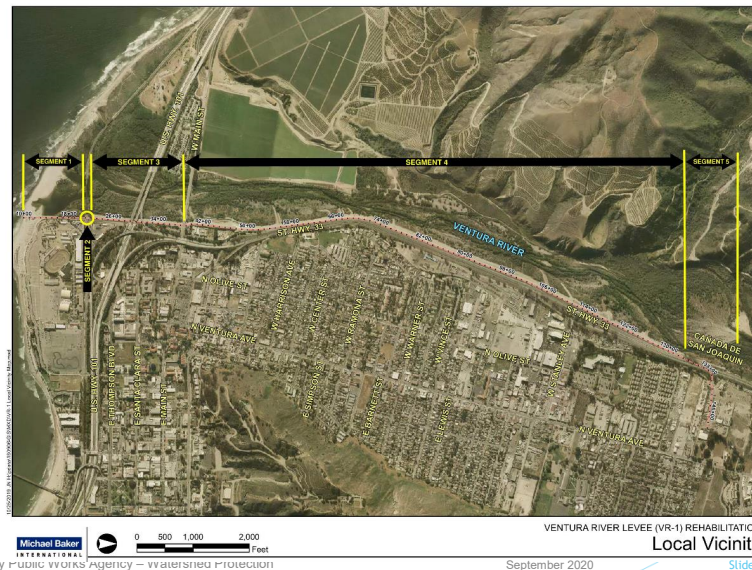
VR-1 Levee Project Segments

For purposes of the analysis and identifying localized areas of modifications and improvements, the VR-1 levee has been divided into five segments.

Segment 1 extends northerly from the downstream limits of the VR-1 levee at the Pacific Ocean upstream to the railroad crossing.

Segment 2 consists of the Union Pacific Railroad right-of-way.

Segment 3 extends approximately from the railroad right-of-way upstream to Main Street.

Segment 4 extends from Main Street upstream to the State Route 33 crossing.

Segment 5 includes the upstream end of the levee from the State Route 33 crossing, extending east to high ground south of Cañada De San Joaquin.

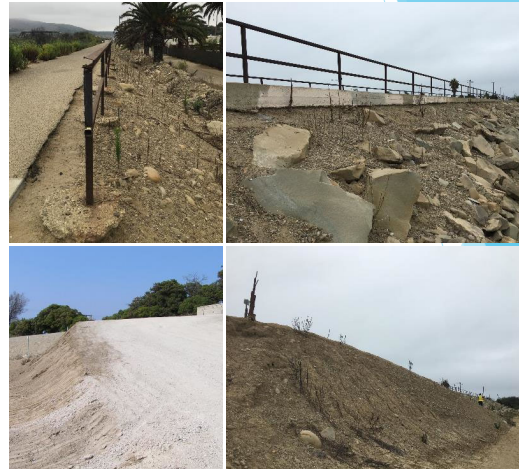
- ▶ Levee is beyond capital service life (72 years old)
- ▶ Levee has structural deficiencies
- ▶ Upgrades required for FEMA certification
- ▶ Community flood protection

Second, the levee also has structural deficiencies including: inadequate bank protection; erosion; and slope instability.

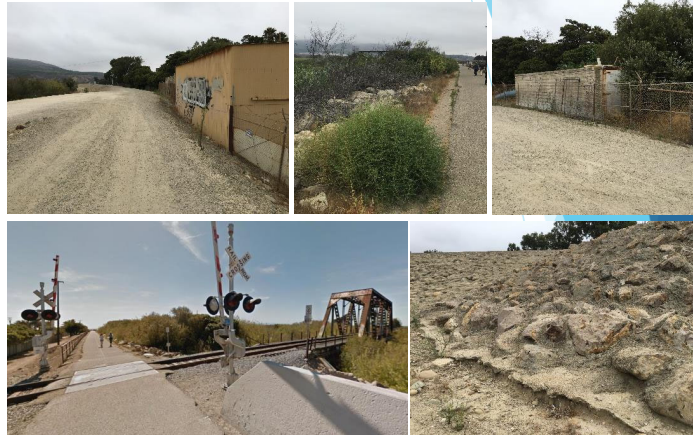
Ventura River VR-1 System Deficiencies

- ▶ Encroachments into levee
- ▶ Vegetation Management
- ▶ Toe-down scour protection
- ▶ Freeboard
- ▶ Railroad Gap

There are multiple unpermitted encroachments into the levee area such as buildings, storage sheds, or other structures.

There is also overgrown vegetation along the levee that needs to be removed in order to be in compliance with U.S. Army Corps of Engineers standards for levees.

There is inadequate toe-down scour protection and erosion and undermining of existing bank protection.

Hydraulic modeling and analysis have also indicated that there are portions along the levee with inadequate freeboard where the Ventura River top of water elevation is close to overtopping or will overtop the crown of the levee during the 100-year flood event.

Finally, there is a gap opening along the railroad crossing where flows would not be contained within the river during a flood event.

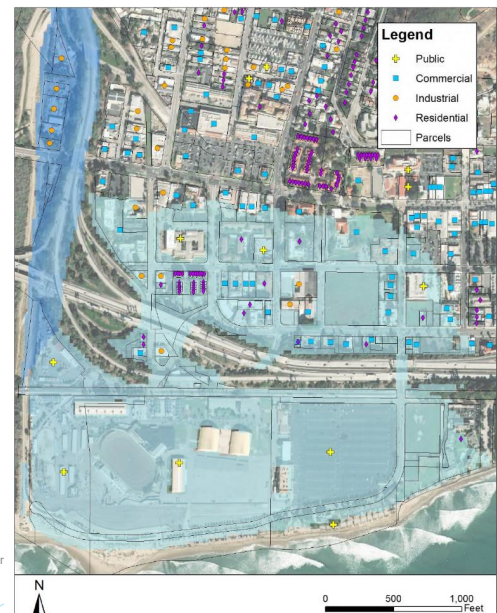
Potential Flood Damage with No Improvements to Segments 1-2 per Scenario 2

Watershed Protection also took a close look at the extent of potential flood damage should no levee improvements be made along Segments 1 and 2 per Scenario. The image shown here indicates the extent of flooding and the gaps along the local street under crossings along Highway 101.

The economic analysis indicated there could be a potential of 41 million dollars in damage to the 66 structures within the flooded area.

Therefore, Scenario 2 was augmented with a flood gate at Garden Street to prevent these impacts.
