FEMA PAL Response Report

SANTA CLARA RIVER LEVEE (SCR-1)

HIGHWAY 101 TO SATICOY

FEMA ID No. 18

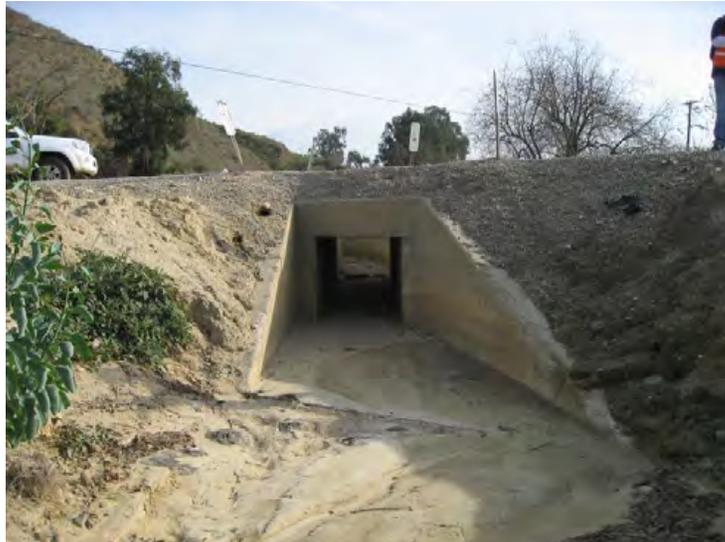
Santa Clara River Levee, From Hwy 101 to Saticoy. (Photo No. P1 – Side drain 1-A, 4' x 4' R.C.B located at upstream end of levee (riverward side))

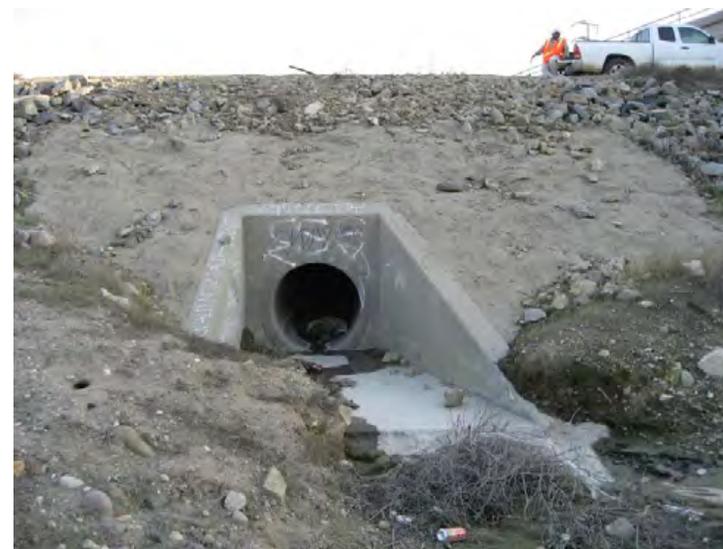
Santa Clara River Levee, From Hwy 101 to Saticoy. (Photo No. P3) – Side Drain No. 2, 48'' RCP located just U/S of L.A. Ave. (riverward side)

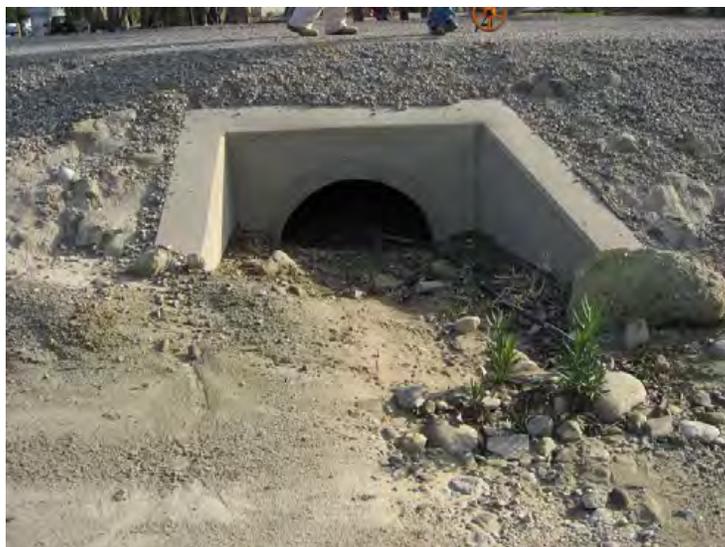
Santa Clara River Levee, From Hwy 101 to Saticoy. (Photo No. P2) – Side Drain No. 1, 42'' RCP (riverward side)

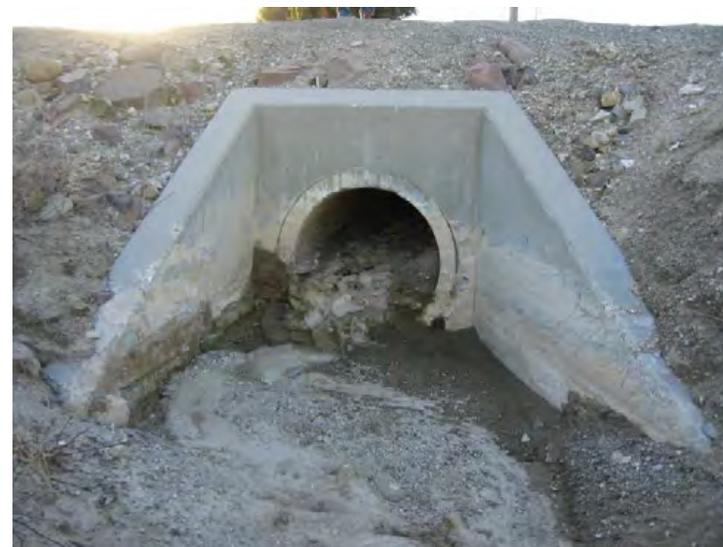
Santa Clara River Levee, From Hwy 101 to Saticoy. (Photo No. P4) – Side Drain No. 3, 48'' RCP (riverward side)

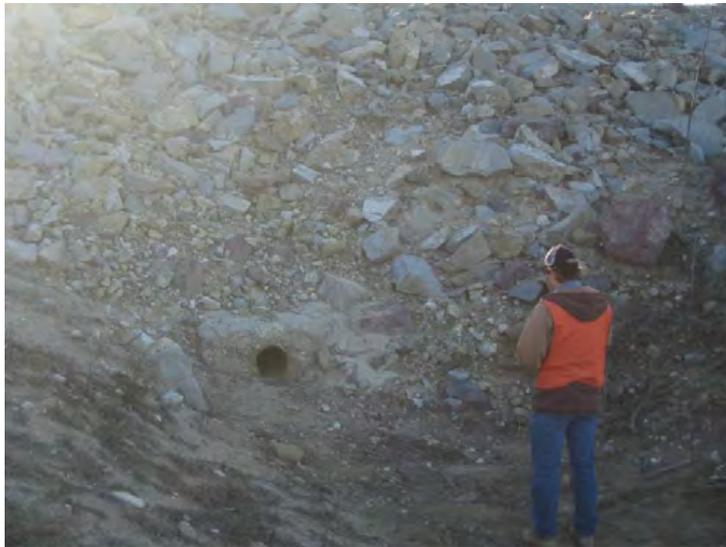
Santa Clara River Levee, From Hwy 101 to Saticoy. (Photo No. P5) – 12” metal pipe, commercial drain from process plant (riverward side)

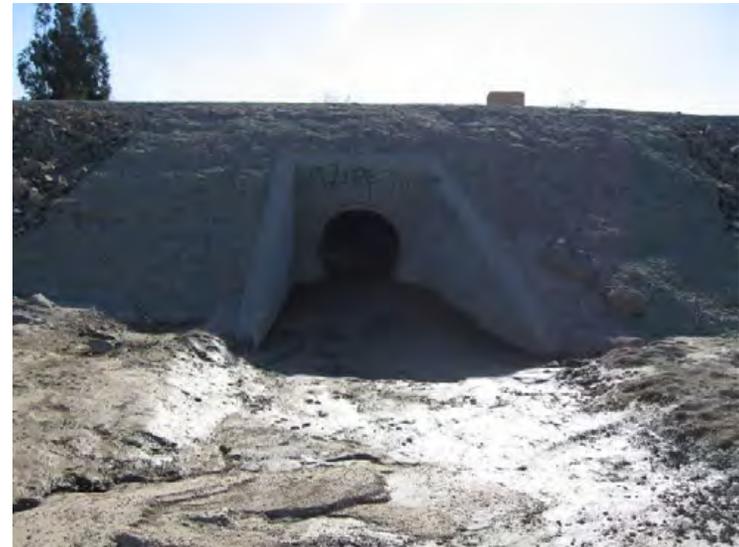
Santa Clara River Levee, From Hwy 101 to Saticoy. (Photo No. P7) – Side Drain No. 4, 48” RCP (riverward side)

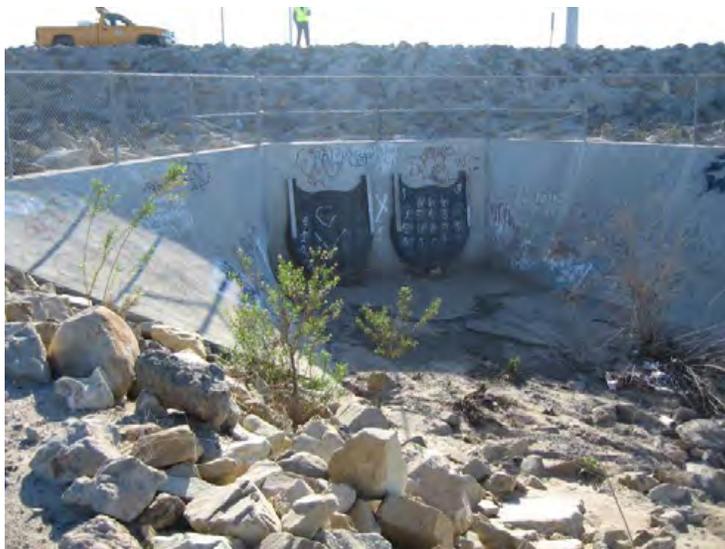
Santa Clara River Levee, From Hwy 101 to Saticoy. (Photo No. P6) – Central Avenue Drain, 2-72” RCP with flap gates (riverward side)

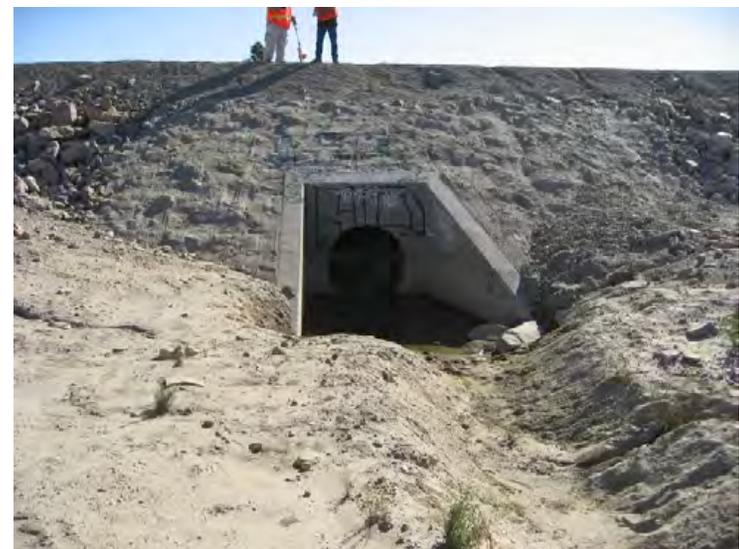
Santa Clara River Levee, From Hwy 101 to Saticoy. (Photo No. P8) – Side Drain No. 6, 48” RCP

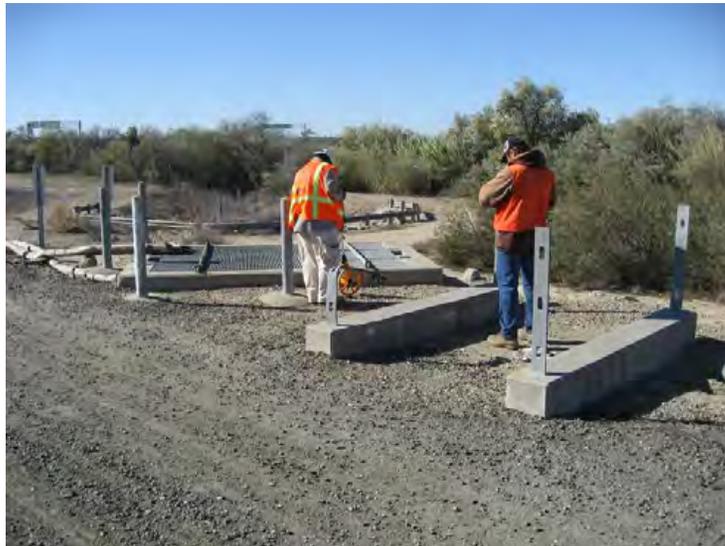
Santa Clara River Levee, From Hwy 101 to Saticoy. (Photo No. P9) –
Stroube Drain – Unit I, Stop Log Structure looking downstream

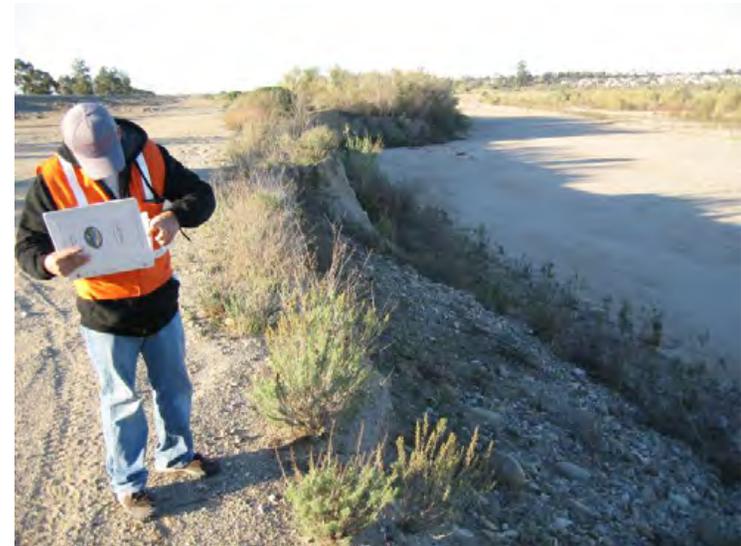
Santa Clara River Levee, From Hwy 101 to Saticoy. (Photo No. F1) –
20' -25' high erosion cut eroding towards levee, looking d/s (riverward)

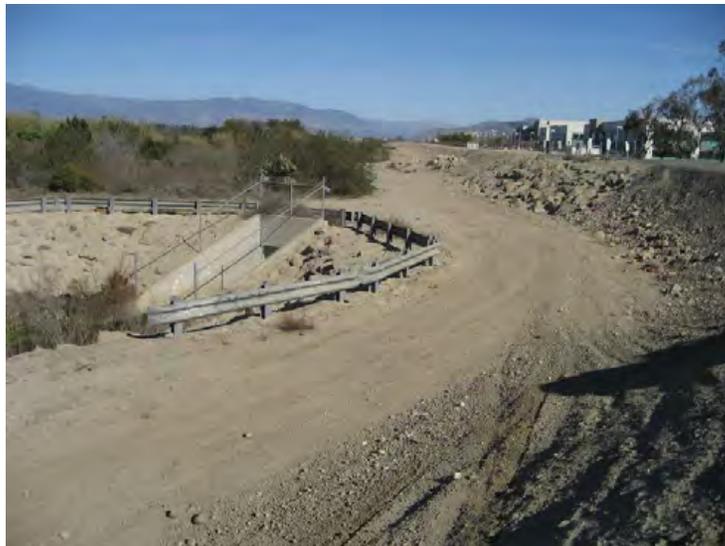
Santa Clara River Levee, From Hwy 101 to Saticoy. (Photo No. P10) –
Stroube Drain – Unit I, 10' Wx8' H RCB looking upstream

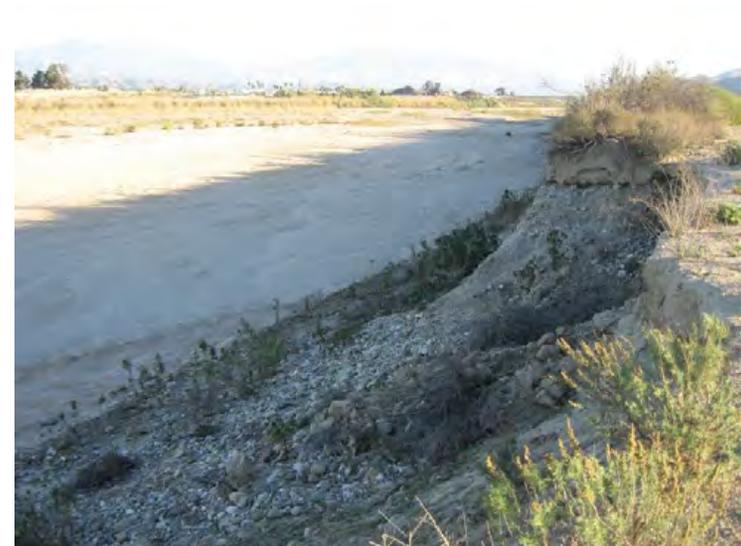
Santa Clara River Levee, From Hwy 101 to Saticoy. (Photo No. F2) –
20' -25' high erosion cut eroding towards levee, looking u/s (riverward)

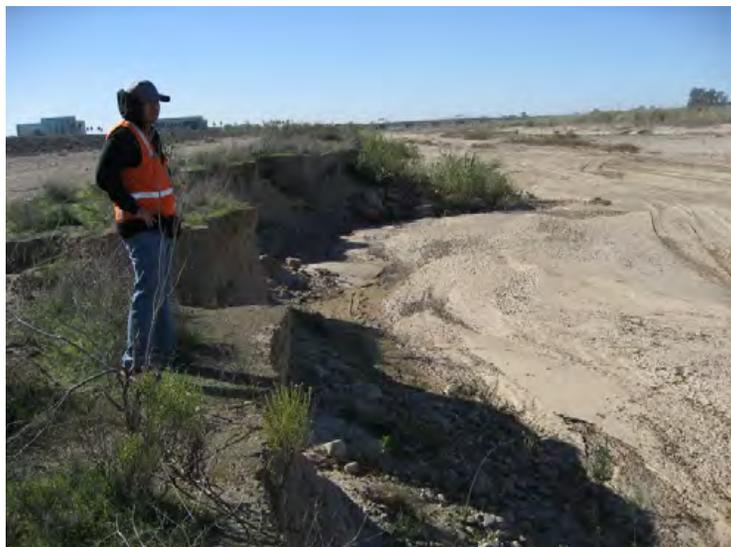
Santa Clara River Levee, From Hwy 101 to Saticoy. (Photo No. F3) – Erosion cut eroding towards levee exposing groins, looking d/s (riverward)

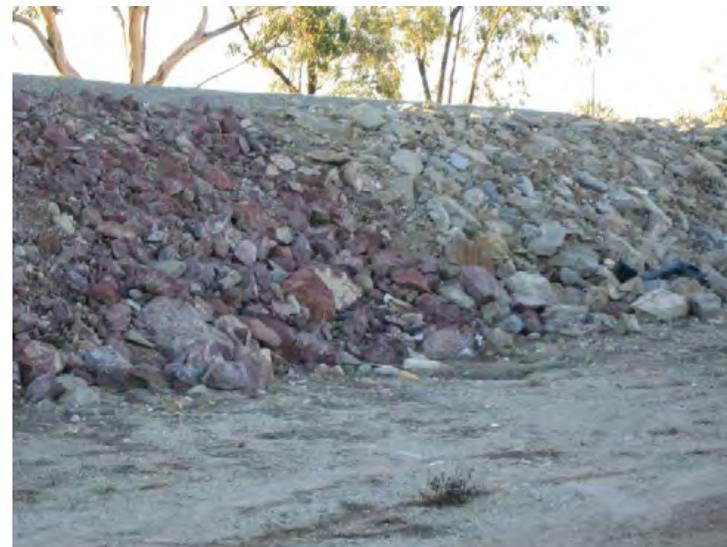
Santa Clara River Levee, From Hwy 101 to Saticoy. (Photo No. F5) – Levee bank stone protection, two different types of stone (riverward side)

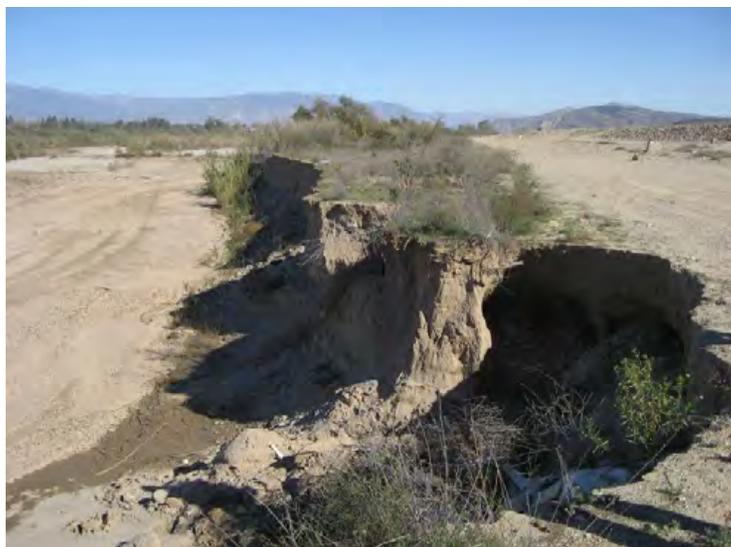
Santa Clara River Levee, From Hwy 101 to Saticoy. (Photo No. F4) – Erosion cut eroding towards levee exposing groins, looking u/s (riverward)

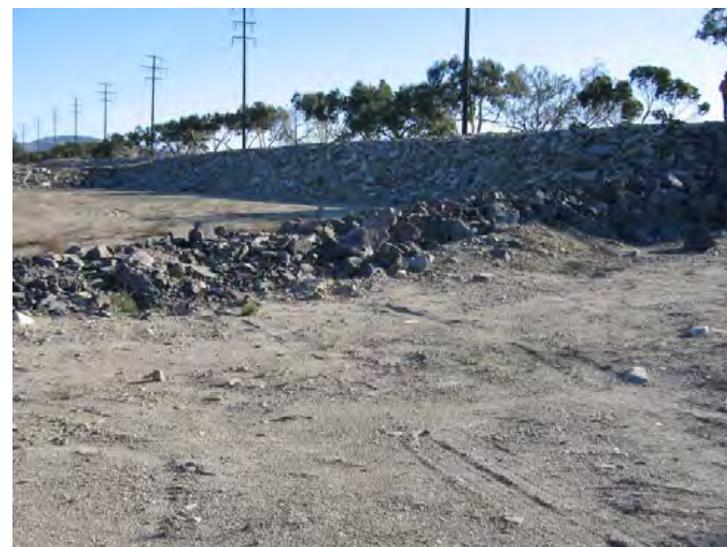
Santa Clara River Levee, From Hwy 101 to Saticoy. (Photo No. F6) – Groin and levee embankment, looking downstream (riverward side)

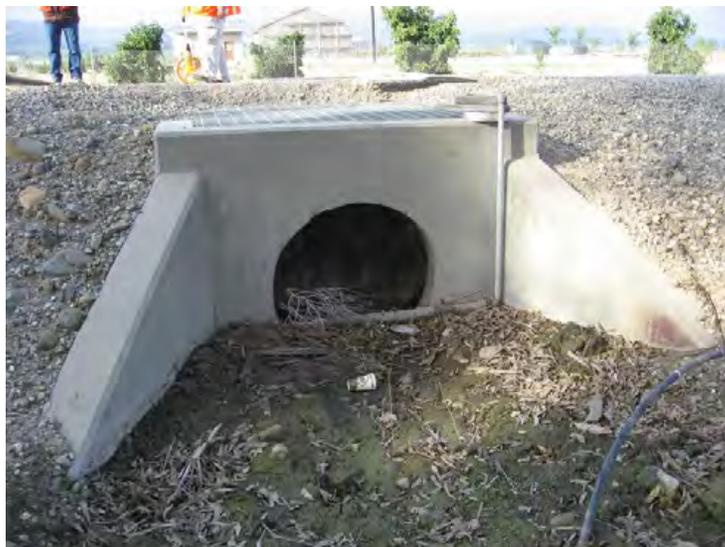
Santa Clara River Levee, From Hwy 101 to Saticoy. (Photo No. M5) –
Sediment deposition in Side Drain No. 1, 42” RCP inlet (landward side)

1. Removal of sediment that has accumulated in most pipe penetrations/structures is required to allow drainage and proper operation of the closure devices (flap gates).
2. Restoration of top and embankment is required in certain locations due to unauthorized vehicle ramps, off-road vehicle rutting, rock revetment sloughing, and runoff erosion.
3. Rock revetment is of several different types (sandstone/igneous/conglomerate) of rock, a lot of which is desiccated and broken down into smaller pieces along the entire length of the levee. The ability of this rock revetment to provide the appropriate level of protection is questionable.
4. Restoration of top and embankment is required in extensive stretches of the levee due to unauthorized dumping/washing out of concrete trucks obscuring any observation of riprap.

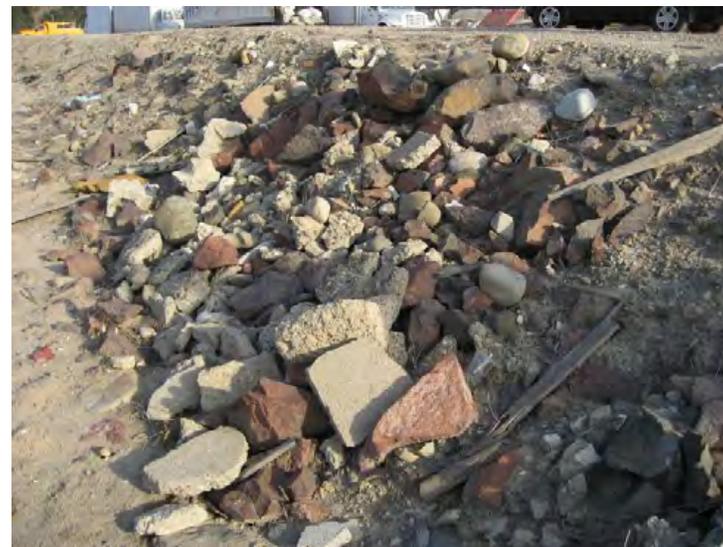
Santa Clara River Levee, From Hwy 101 to Saticoy. (Photo No. M7) –
Wood debris adjacent to nursery looking upstream (riverward side)

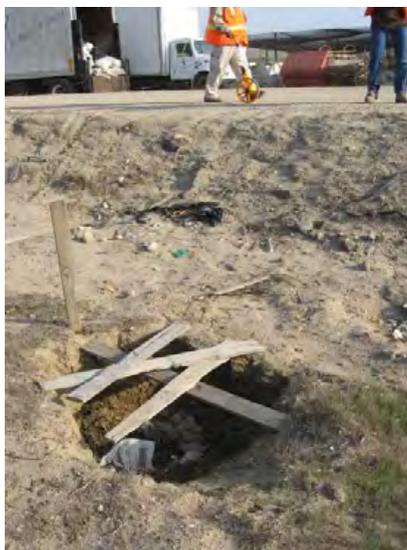
Santa Clara River Levee, From Hwy 101 to Saticoy. (Photo No. M6) –
Wood debris adjacent to nursery looking upstream (riverward side)

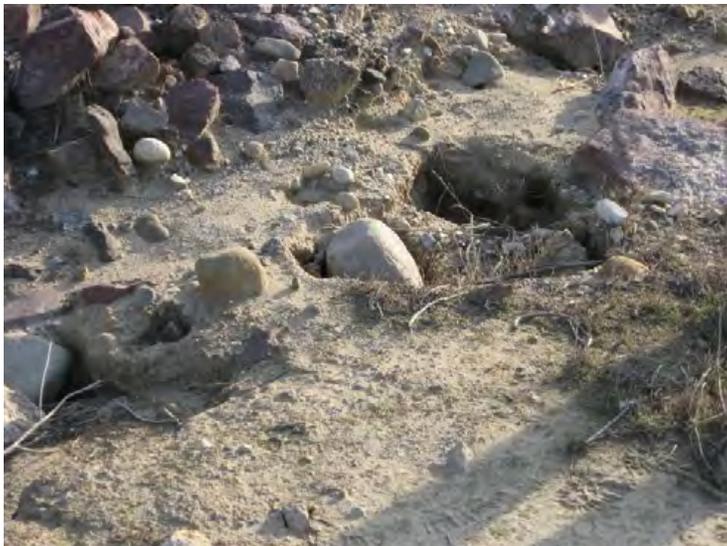
9. Multiple animal burrows were observed in the field.

Santa Clara River Levee, From Hwy 101 to Saticoy. (Photo No. M10) –
Animal burrows at levee toe (riverward side)

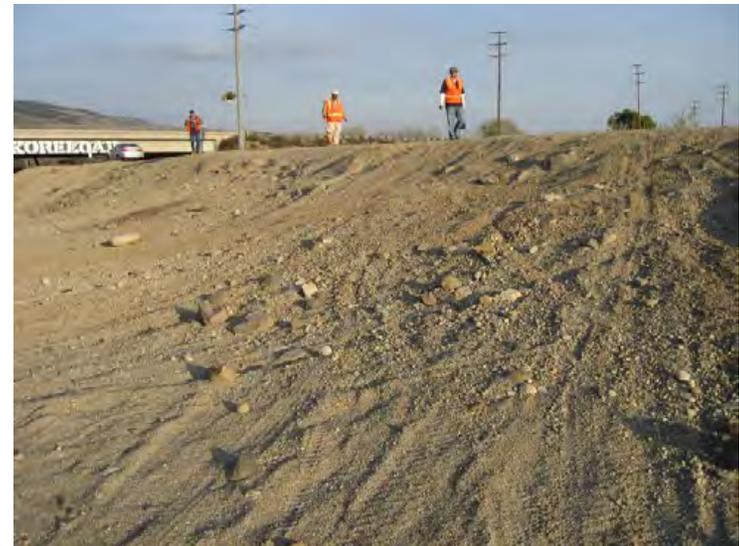
Santa Clara River Levee, From Hwy 101 to Saticoy. (Photo No. M12) –
Erosion of levee embankment just downstream of L.A. Ave.(riverward side)

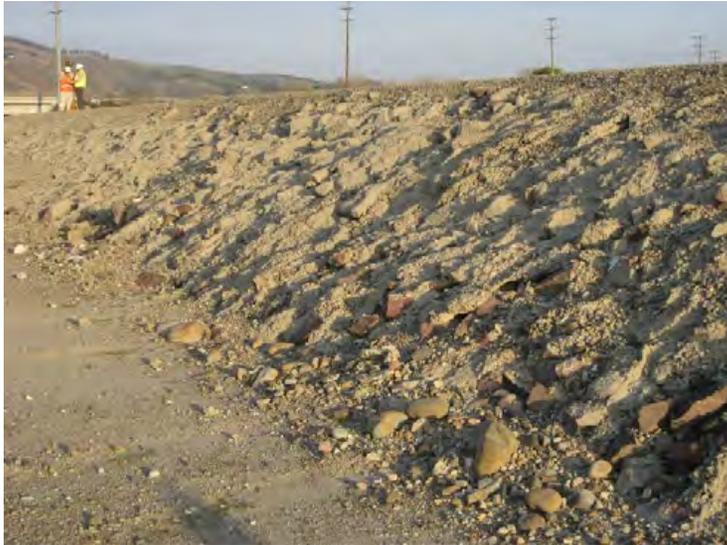
Santa Clara River Levee, From Hwy 101 to Saticoy. (Photo No. M13) –
Concrete spread over levee embankment, looking d/s (riverward side)

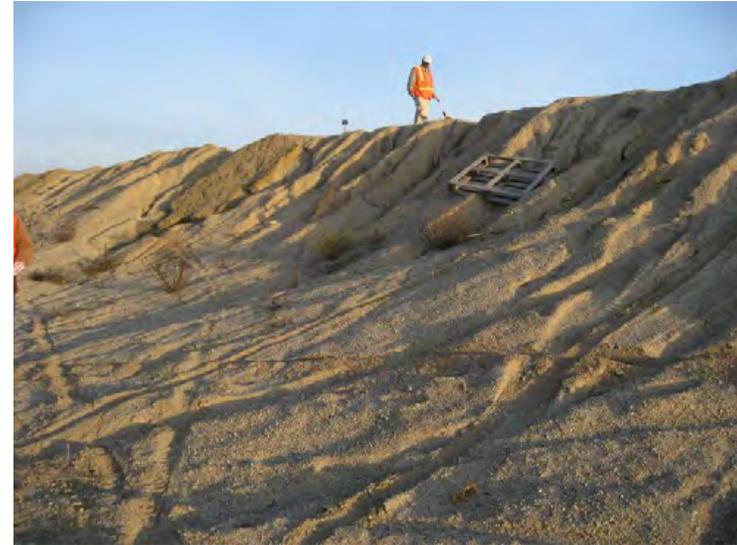
Santa Clara River Levee, From Hwy 101 to Saticoy. (Photo No. M15) –
Erosion of levee embankment, looking upstream (riverward side)

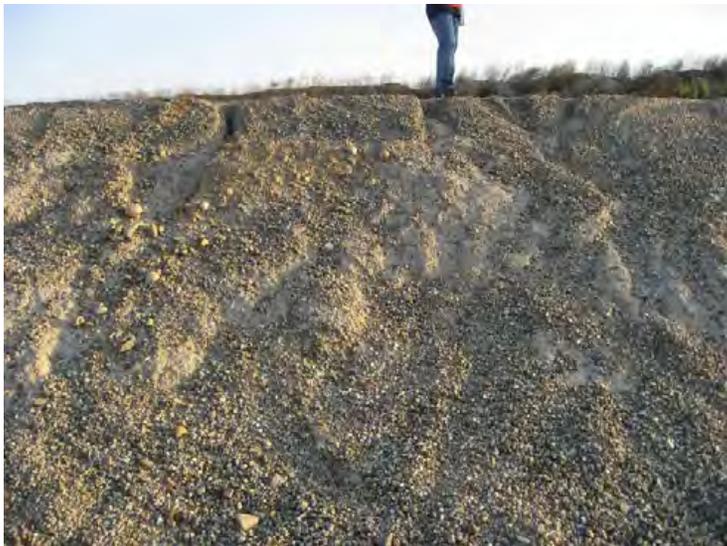
Santa Clara River Levee, From Hwy 101 to Saticoy. (Photo No. M14) –
Erosion on levee embankment, looking d/s (riverward side)

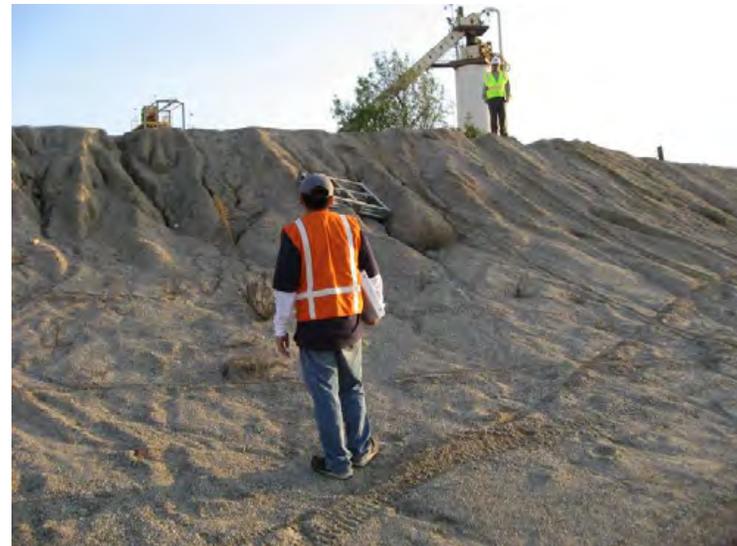
Santa Clara River Levee, From Hwy 101 to Saticoy. (Photo No. M16) –
Erosion of levee embankment, adjacent to asphalt plant (riverward side)

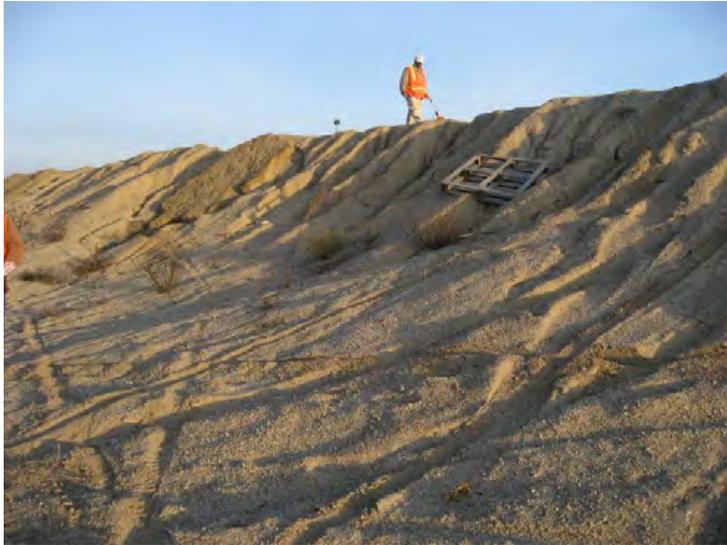
Santa Clara River Levee, From Hwy 101 to Saticoy. (Photo No. M17) –
Erosion of levee embankment, adjacent to asphalt plant (riverward side)

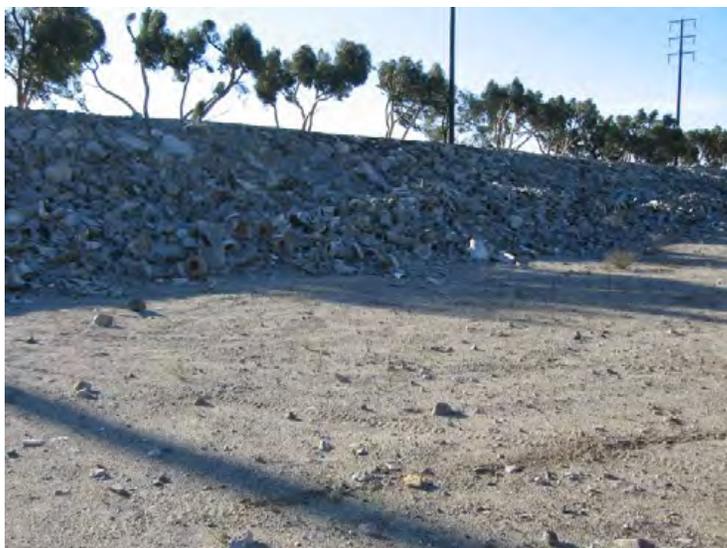
Santa Clara River Levee, From Hwy 101 to Saticoy. (Photo No. M26) –
Concrete pipe debris along levee toe, looking d/s (riverward side)

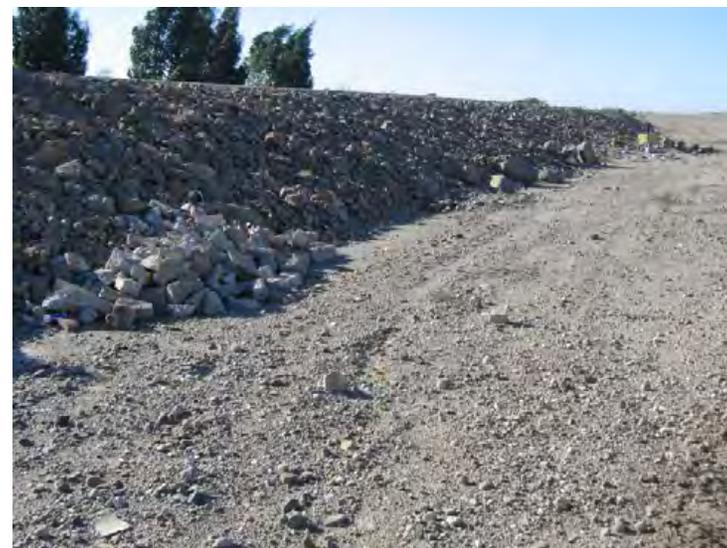
Santa Clara River Levee, From Hwy 101 to Saticoy. (Photo No. M28) –
Debris along levee toe, looking downstream (riverward side)

M27	Unauthorized ramp on levee (riverward side)	Remove unauthorized earthen ramp	C1/C4	E2	Redress levee slope in kind repair			
M28	Debris stock piles along levee toe (riverward side)	Remove unauthorized debris stockpiles from levee toe	C1	E1	Remove debris			
M29	Sediment deposition in Side Drain No. 6, 48" RCP outlet (riverward side)	Remove sediment and debris and establish a clear passage from pipe to channel (riverward & landward sides)	C1	E1	Remove sediment			
M30	Unauthorized ramp on levee	Remove unauthorized debris stockpiles from levee toe	C1/C4	E2	Remove ramp, in kind repair			
M31	Sloughing levee embankment protection (riverward side)	Reestablish levee embankment and fill voids with impervious material and firmly compact	C1/C4	E2	Redress levee slope in kind repair			
M32	Sediment deposition in Side Drain No. 4, 48" RCP outlet (riverward side)	Remove sediment and establish a clear passage from pipe to channel (riverward & landward sides)	C1/C4	E2	Excavate sediment to drain properly

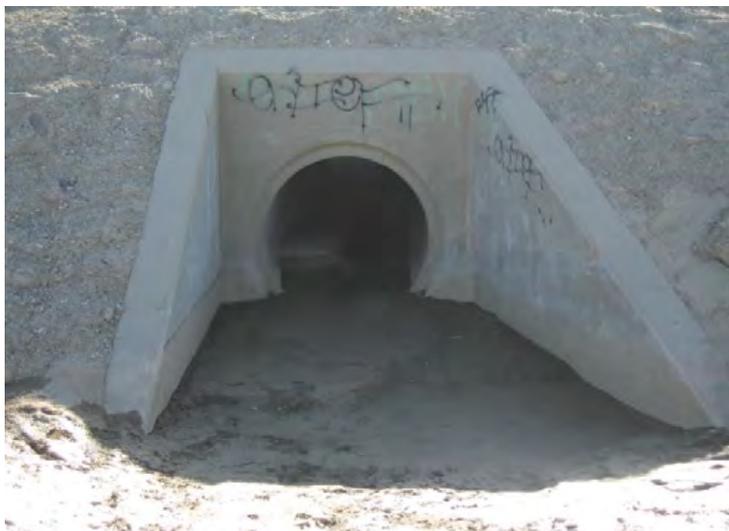
Santa Clara River Levee, From Hwy 101 to Saticoy. (Photo No. M29) – Sediment deposition in Side Drain No. 6, 48” RCP outlet (riverward side)

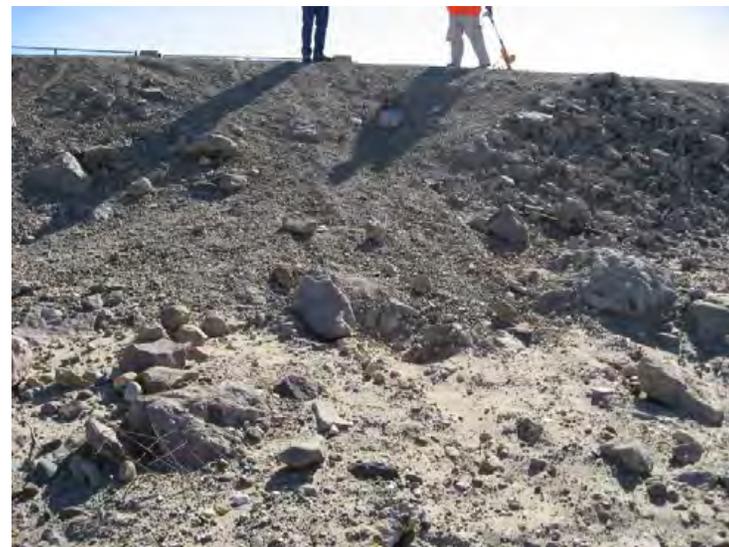
Santa Clara River Levee, From Hwy 101 to Saticoy. (Photo No. M31) – Sloughing levee embankment protection (riverward side)

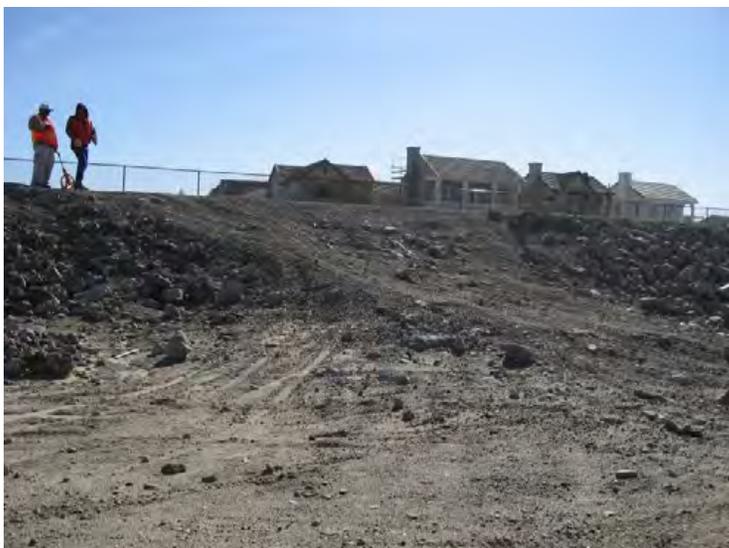
Santa Clara River Levee, From Hwy 101 to Saticoy. (Photo No. M30) – Unauthorized ramp on levee (riverward side)

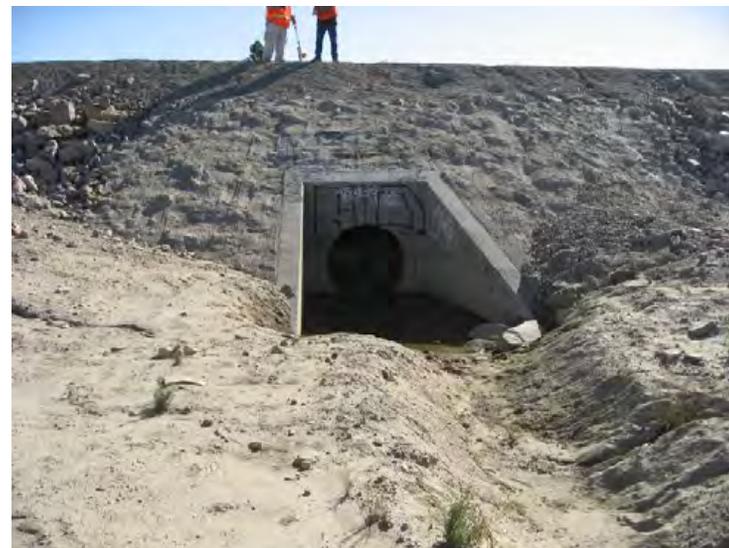
Santa Clara River Levee, From Hwy 101 to Saticoy. (Photo No. M32) – Sediment deposition in Side Drain No. 4, 48” RCP outlet (riverward side)

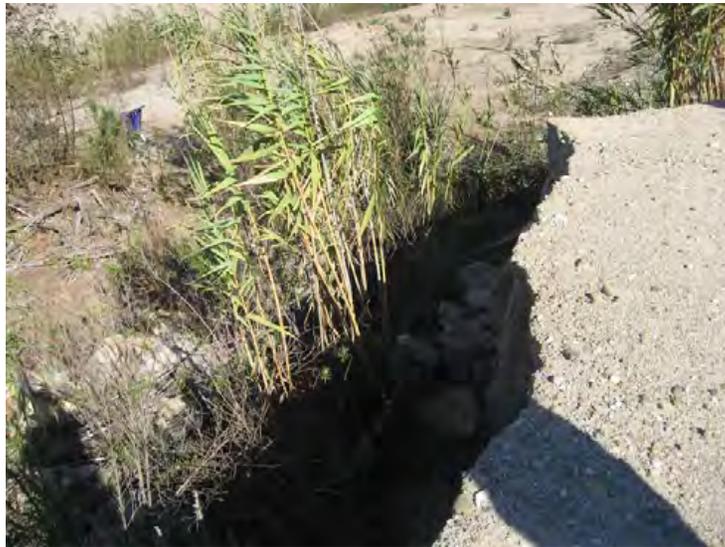
Santa Clara River Levee, From Hwy 101 to Saticoy. (Photo No. M33) – Exposure of tip of buried groin looking downstream (riverward side)

M33, M34	Tip of buried groin is exposed and sink holes are present in soil covering groins (riverward side)	Repair sinkholes and fill voids with impervious material and firmly compact. (Safety Hazard) Additional engineering analysis is recommended for exposed groins	C5 - D&C to rebuild groin	E3	Excavate/repair groin may need fish permit			
M35, M36	Tip of buried groin is exposed and sink holes are present in soil covering groins (riverward side)	Repair sinkholes and fill voids with impervious material and firmly compact. (Safety Hazard) Additional engineering analysis is recommended for exposed groins	C5 - D&C to rebuild groin	E2	Likely do in concert with M33, M34			
M37	Tip of buried groin is exposed (riverward side)	Additional engineering analysis is recommended for exposed groins	C5 - D&C to rebuild groin	E3	Excavate/repair groin may need fish permit			
M38	Unauthorized ramp with missing levee embankment protection (riverward side)	Remove unauthorized earthen ramp and reestablish levee embankment and embankment protection	C1/C4	E2	Remove ramp, in kind repair

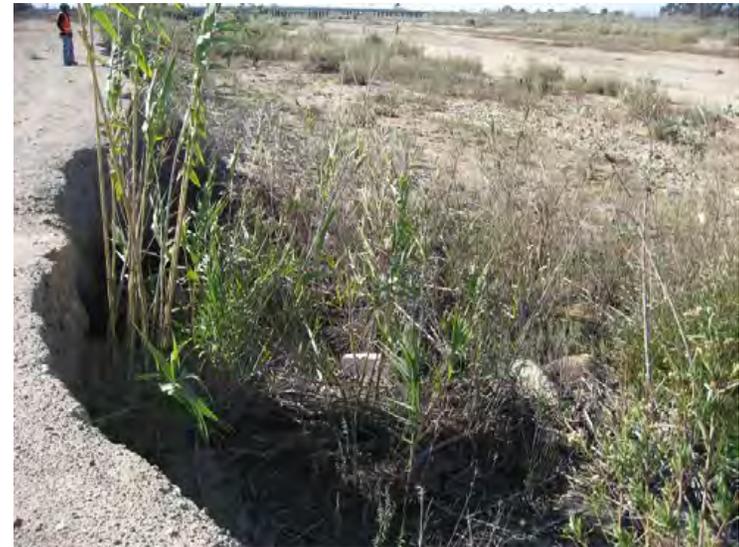
Santa Clara River Levee, From Hwy 101 to Saticoy. (Photo No. M35) – Exposure of tip of buried groin looking downstream (riverward side)

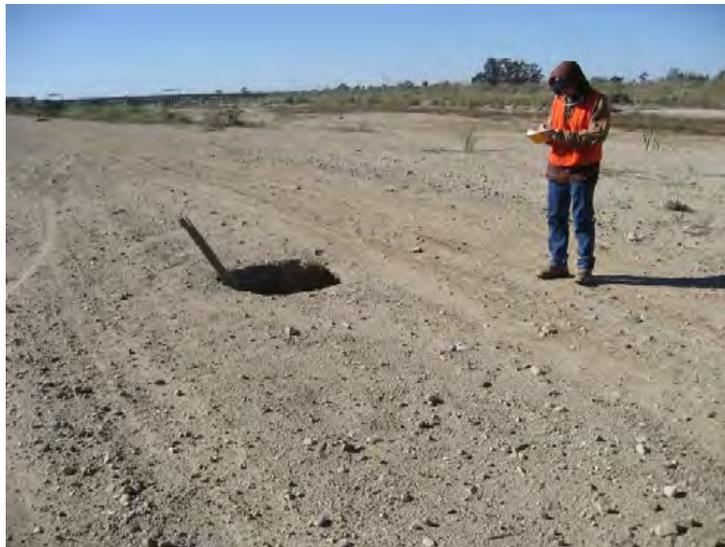
Santa Clara River Levee, From Hwy 101 to Saticoy. (Photo No. M34) – Sink hole in soil covering buried groins looking down/s (riverward side)

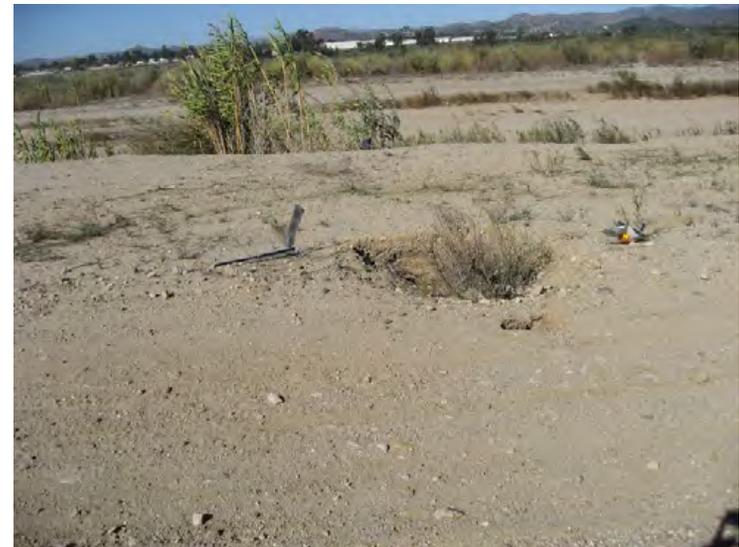
Santa Clara River Levee, From Hwy 101 to Saticoy, (Photo No. M36) – Sink hole in soil covering buried groins (riverward side)

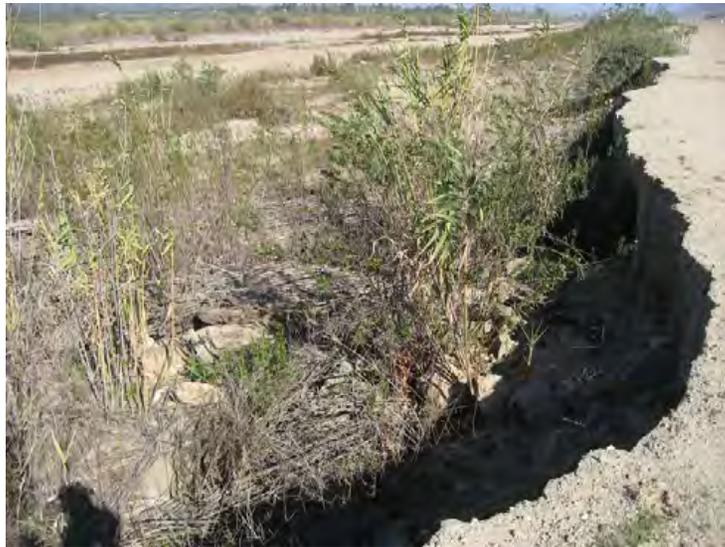
Santa Clara River Levee, From Hwy 101 to Saticoy. (Photo No. M37) – Exposure of tip of buried groin, looking upstream (riverward side)

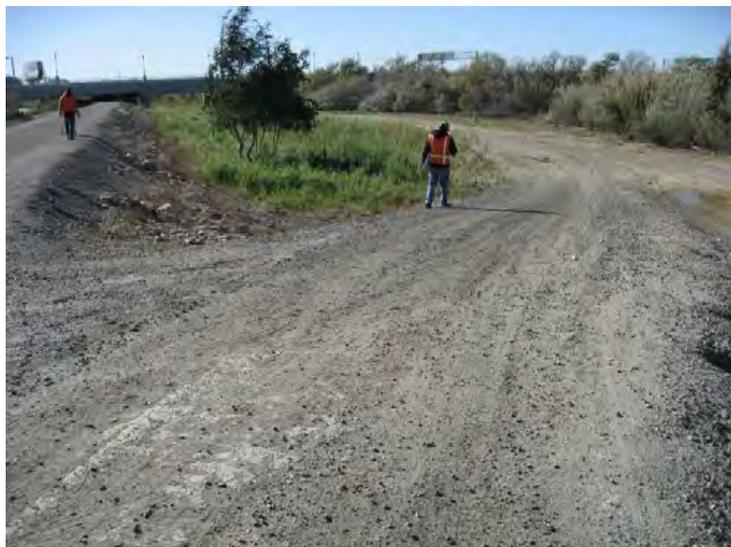
Santa Clara River Levee, From Hwy 101 to Saticoy. (Photo No. M41) –
Vegetation within 15' levee toe, looking d/s (riverward side)

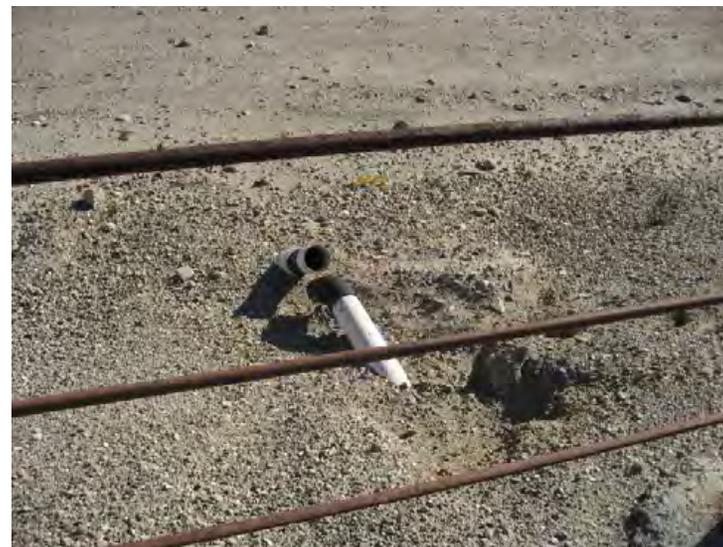
Santa Clara River Levee, From Hwy 101 to Saticoy, (Photo No. M43) –
PVC pipe protruding from levee (landward side)

M43	PVC pipe protruding from top of levee (landward side)	Remove unauthorized PVC pipe and fill voids with impervious material and firmly compact	C1/C4	E1	Excavate & repair in kind			
M44	Erosion on top of levee exposing fence posts (landward side)	Reestablish top of levee and fill voids with impervious material and firmly compact	C1/C4	E1	Repair, redress in kind			
M45	Stone debris approximately 500-feet along levee toe (landward side)	Remove unauthorized stone debris from levee toe	C1/C4	E1	Remove debris			
M46	Erosion on top of levee (landward side)	Reestablish top of levee and fill voids with impervious material and firmly compact	C1/C4	E1	Regrade levee top & bank, in kind repair			
M47, M48	Dumped stone and debris approximately 100 feet along the levee (landward side)	Remove unauthorized stone debris from levee toe	C1/C4	E1	Remove debris			
M49, M50	Sediment deposition in Side Drain No. 4, 48" RCP inlet structure (landward side)	Remove sediment and debris and establish a clear passage from pipe to channel (riverward & landward sides)	C1/C4	E1	Remove sediment & debris

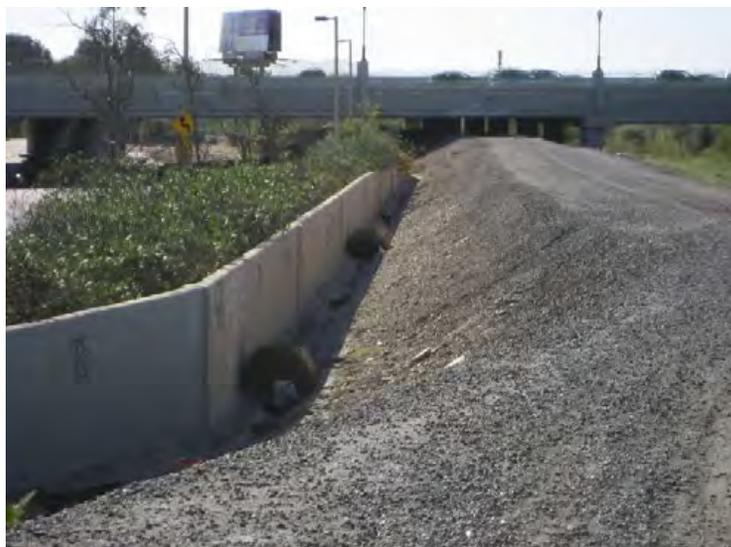
Santa Clara River Levee, From Hwy 101 to Saticoy. (Photo No. M42) –
Vegetation within 15-feet of levee toe looking d/s (landward side)

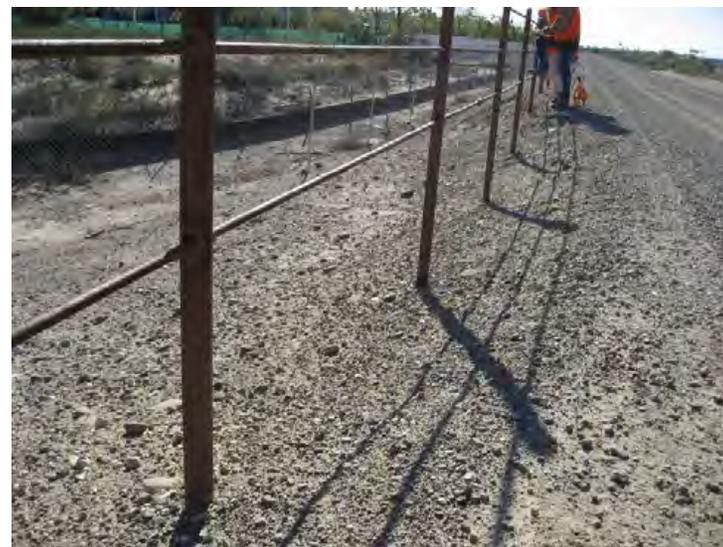
Santa Clara River Levee, From Hwy 101 to Saticoy, (Photo No. M44) –
Erosion on top of levee exposing fence posts, looking d/s (landward side)

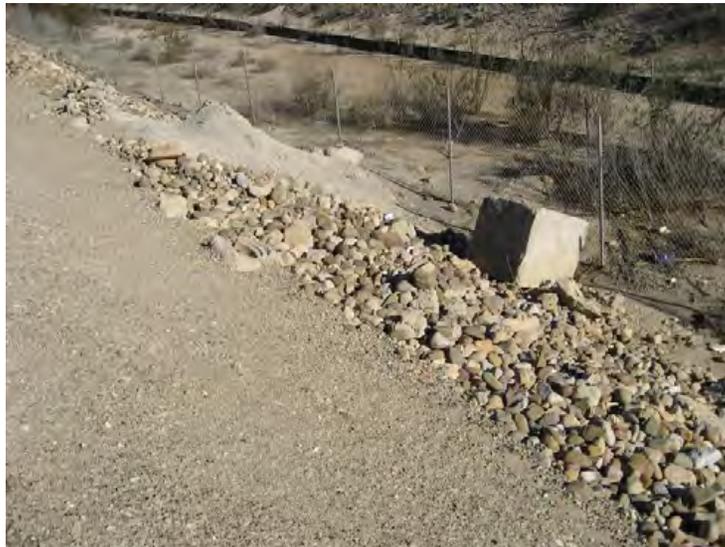
Santa Clara River Levee, From Hwy 101 to Saticoy, (Photo No. M45) –
Stone debris approx. 500’ along levee toe, looking u/s (landward side)

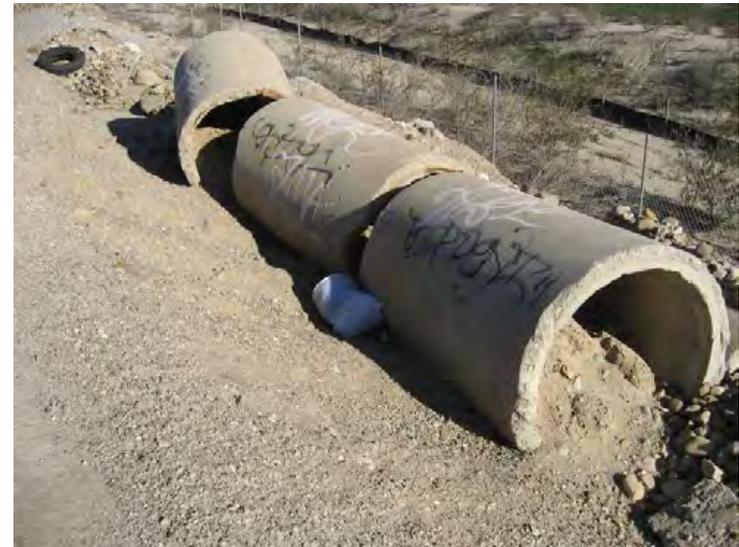
Santa Clara River Levee, From Hwy 101 to Saticoy, (Photo No. M47) –
Debris approx. 100’ along levee, looking u/s (riverward side)

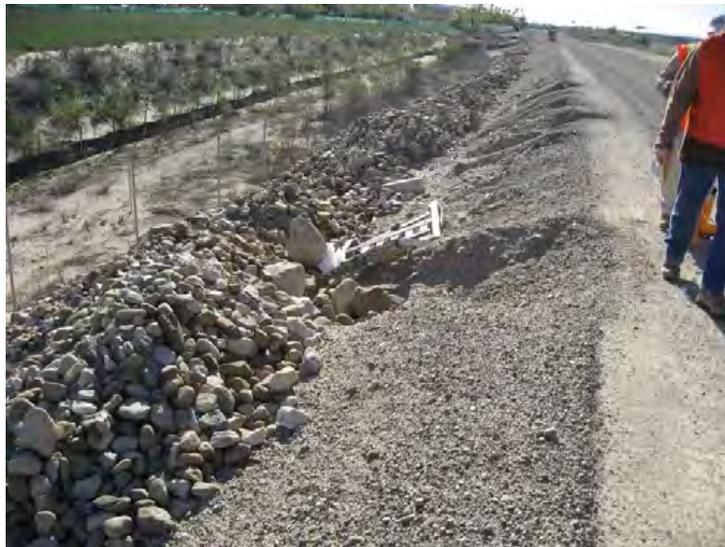
Santa Clara River Levee, From Hwy 101 to Saticoy, (Photo No. M46) –
Erosion on top of levee, looking downstream (riverward side)

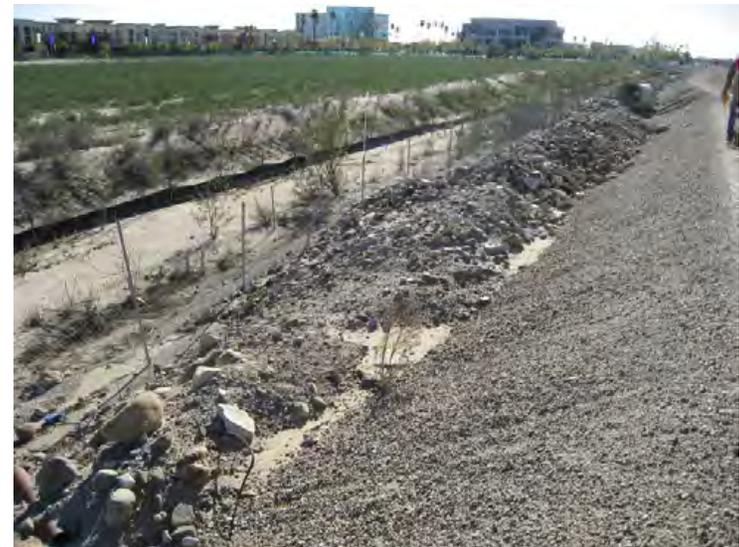
Santa Clara River Levee, From Hwy 101 to Saticoy, (Photo No. M48) –
Debris approx. 100’ along levee, looking u/s (riverward side)

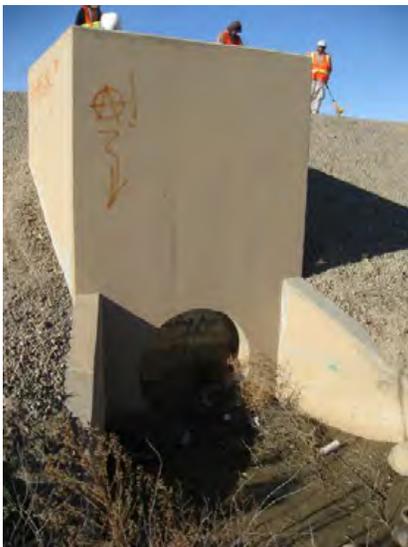
Santa Clara River Levee, From Hwy 101 to Saticoy, (Photo No. M49) –
Sediment deposition in Side Drain No. 4, 48” RCP invert (landward side)

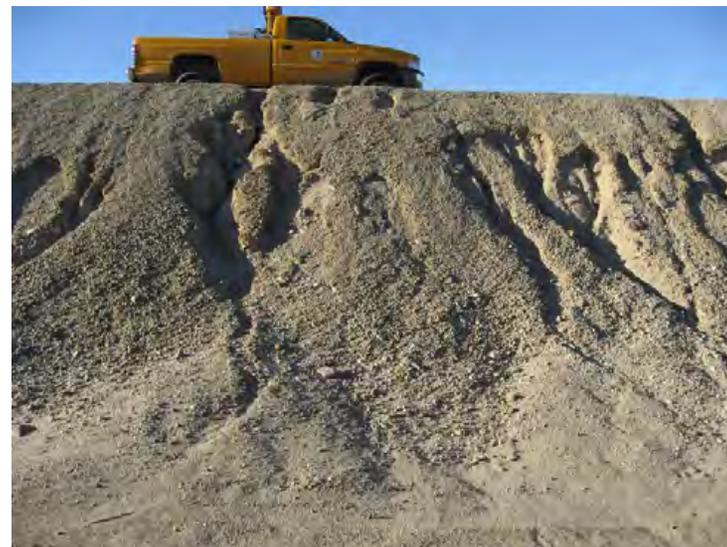
Santa Clara River Levee, From Hwy 101 to Saticoy, (Photo No. M51) –
Erosion on levee embankment, looking upstream (landward side)

M51, M52	Erosion on levee embankment (landward side)	Reestablish levee embankment and fill voids with impervious material and firmly compact	C1/C4	E1	Redress levee slope in kind repair			
M53	Animal burrows near top of levee (landward side)	Remove animal burrows, fill voids with impervious material and firmly compact	C1	E1	Excavate & recompact existing levee, add IPM			
M54	Tree within 15' of levee toe (landward side)	Remove tree and root ball, fill voids with impervious material and firmly compact.	C1/C4	E1	Landward veg removal not regulated	X	Where does the toe start?	The fifteen (15) foot vegetation line is measured from the visual toe of slope to the center line of the trunk (tree), the closest trunk to the toe (multiple trunk trees/plants) or the stock/stem protruding through the soil (large plant connected to a root system)
M55, M56	Trees within 15' along levee toe (landward side)	Remove trees and root ball, fill voids with impervious material and firmly compact.	C1/C4	E1	Landward veg removal not regulated	X	Where does the toe start?	The fifteen (15) foot vegetation line is measured from the visual toe of slope to the center line of the trunk (tree), the closest trunk to the toe (multiple trunk trees/plants) or the stock/stem protruding through the soil (large plant connected to a root system)

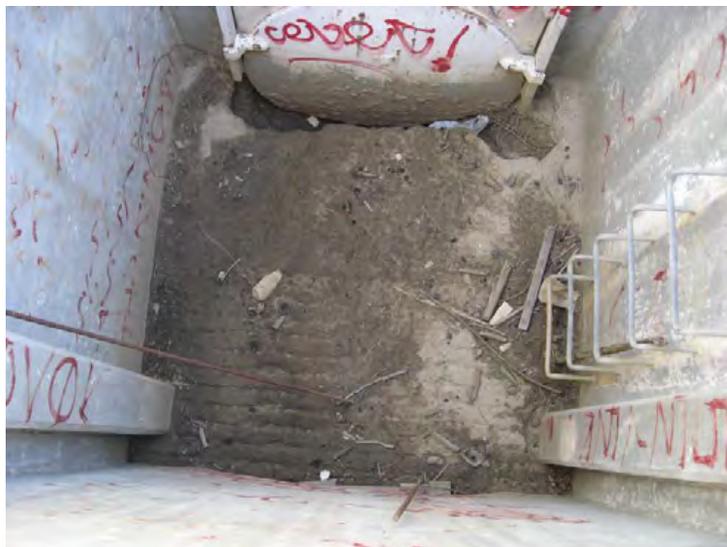
Santa Clara River Levee, From Hwy 101 to Saticoy, (Photo No. M50) –
Looking down at sediment in SD No. 4, inlet structure (landward side)

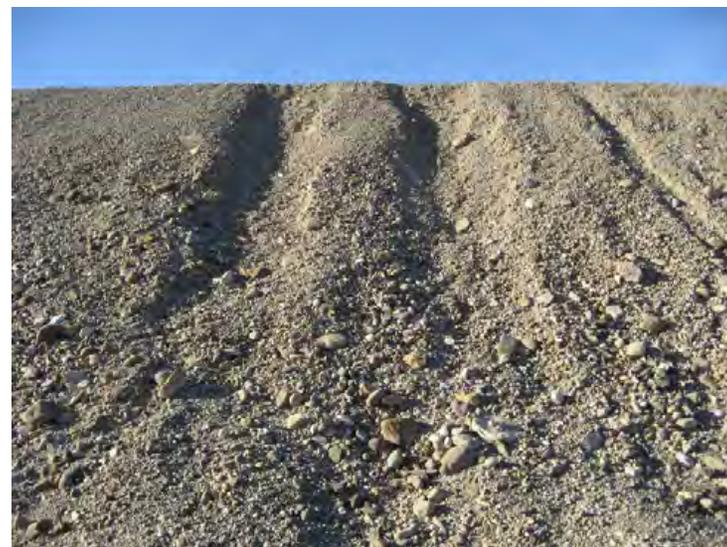
Santa Clara River Levee, From Hwy 101 to Saticoy, (Photo No. M52) –
Erosion on levee embankment, looking downstream (landward side)
