FEMA PAL Response Report

SANTA CLARA RIVER LEVEE (SCR-1)

HIGHWAY 101 TO SATICOY

FEMA ID No. 18

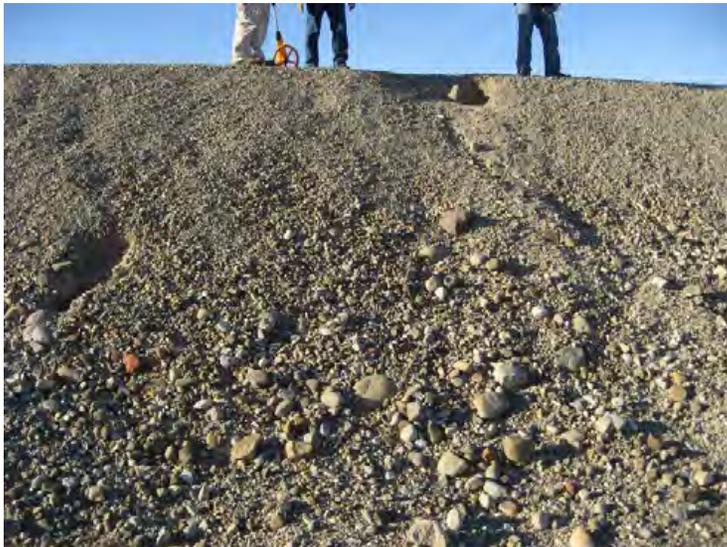
Santa Clara River Levee, From Hwy 101 to Saticoy, (Photo No. M53) –
Animal burrows at top of levee (landward side)

M51, M52	Erosion on levee embankment (landward side)	Reestablish levee embankment and fill voids with impervious material and firmly compact	C1/C4	E1	Redress levee slope in kind repair			
M53	Animal burrows near top of levee (landward side)	Remove animal burrows, fill voids with impervious material and firmly compact	C1	E1	Excavate & recompact existing levee, add IPM			
M54	Tree within 15' of levee toe (landward side)	Remove tree and root ball, fill voids with impervious material and firmly compact.	C1/C4	E1	Landward veg removal not regulated	X	Where does the toe start?	The fifteen (15) foot vegetation line is measured from the visual toe of slope to the center line of the trunk (tree), the closest trunk to the toe (multiple trunk trees/plants) or the stock/stem protruding through the soil (large plant connected to a root system)
M55, M56	Trees within 15' along levee toe (landward side)	Remove trees and root ball, fill voids with impervious material and firmly compact.	C1/C4	E1	Landward veg removal not regulated	X	Where does the toe start?	The fifteen (15) foot vegetation line is measured from the visual toe of slope to the center line of the trunk (tree), the closest trunk to the toe (multiple trunk trees/plants) or the stock/stem protruding through the soil (large plant connected to a root system)

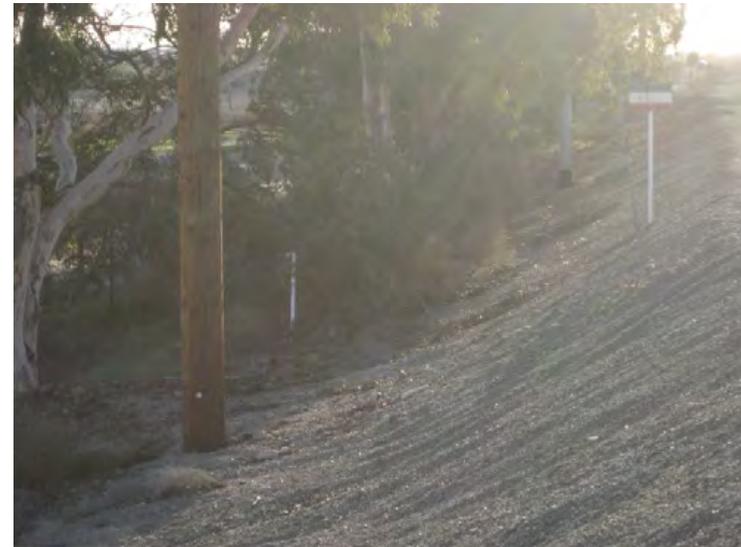
Santa Clara River Levee, From Hwy 101 to Saticoy, (Photo No. M55) –
Trees within 15' of levee toe, looking downstream (landward side)

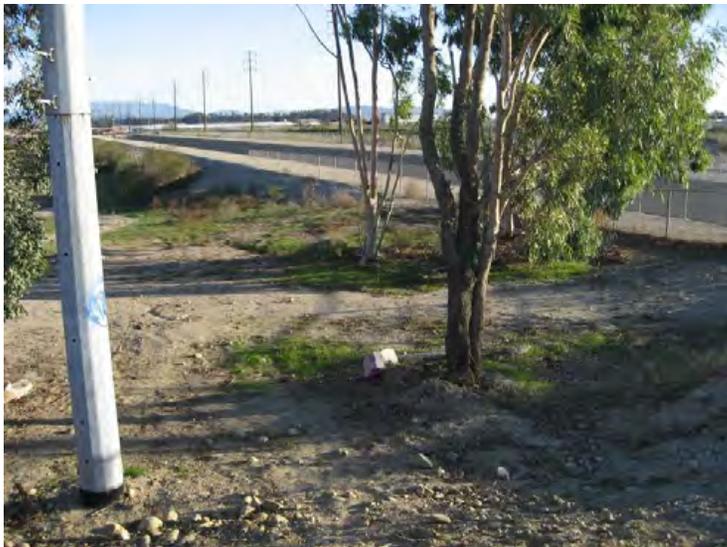
Santa Clara River Levee, From Hwy 101 to Saticoy, (Photo No. M54) –
Tree within 15' of levee toe, looking downstream (landward side)

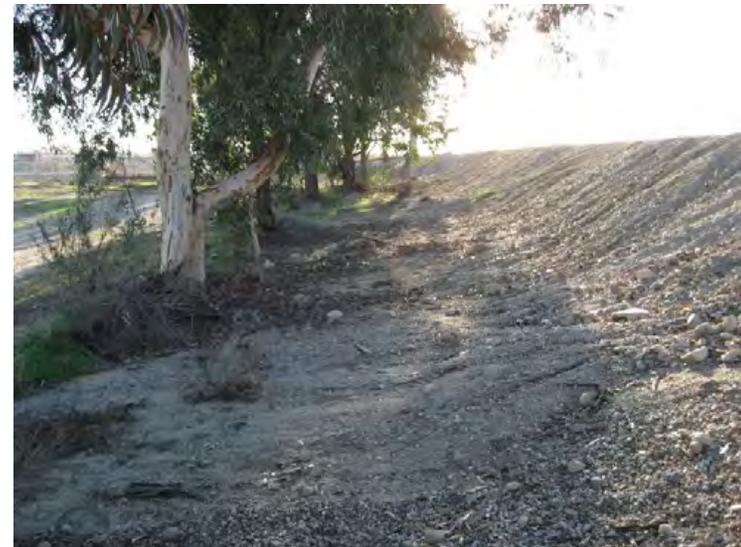
Santa Clara River Levee, From Hwy 101 to Saticoy, (Photo No. M56) –
Trees within 15' of levee toe, looking upstream (landward side)

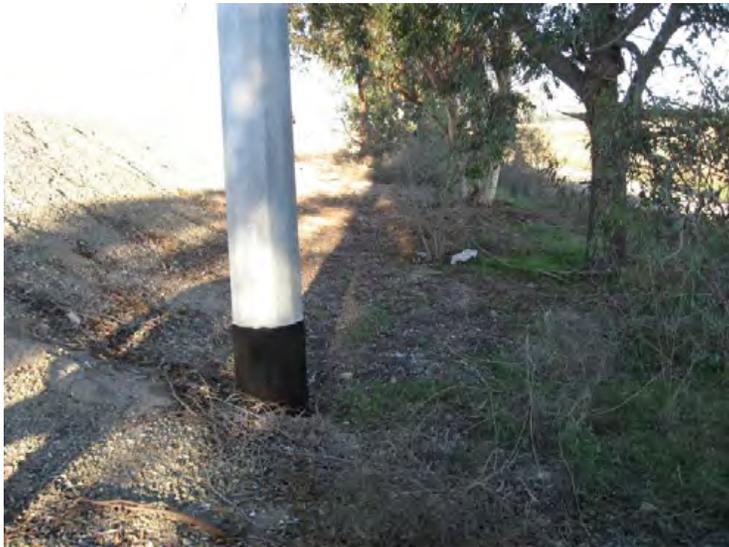
**Santa Clara River Levee, From Hwy 101 to Saticoy, (Photo No. M57) –
Power poles within 15’ of levee toe, looking upstream (landward side)**

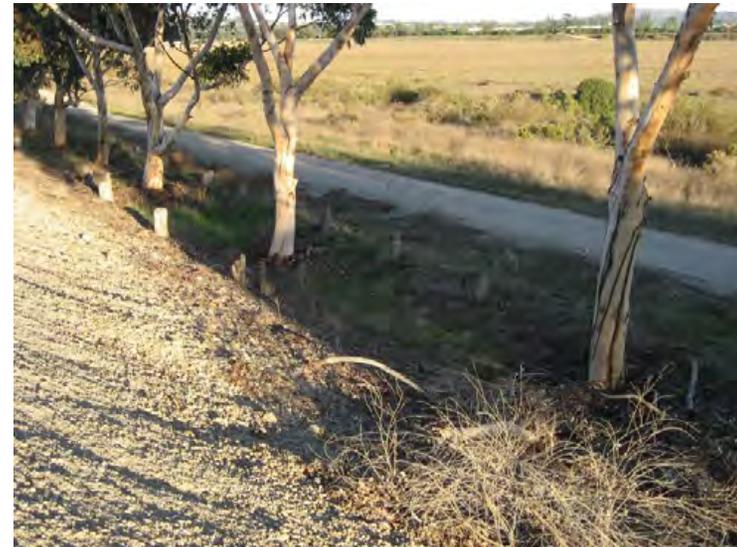
**Santa Clara River Levee, From Hwy 101 to Saticoy, (Photo No. M59) –
Trees within 15’ of levee toe, looking u/s (landward side)**

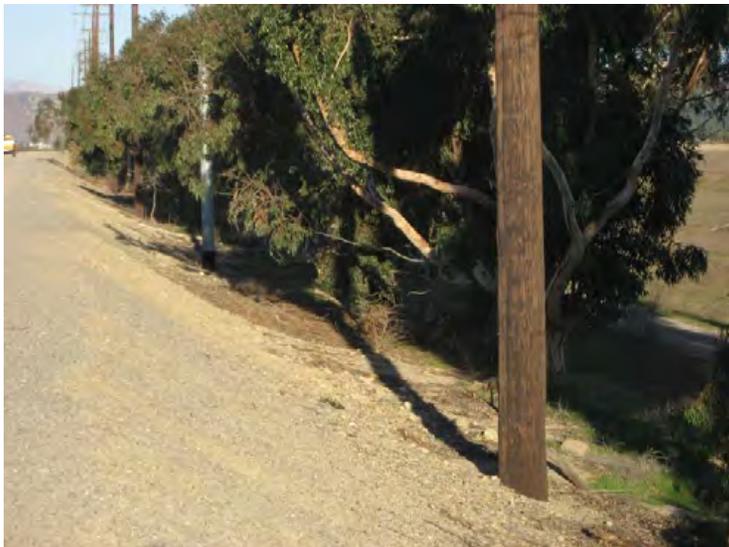
**Santa Clara River Levee, From Hwy 101 to Saticoy, (Photo No. M58) –
Power poles within 15’ of levee toe, looking upstream (landward side)**

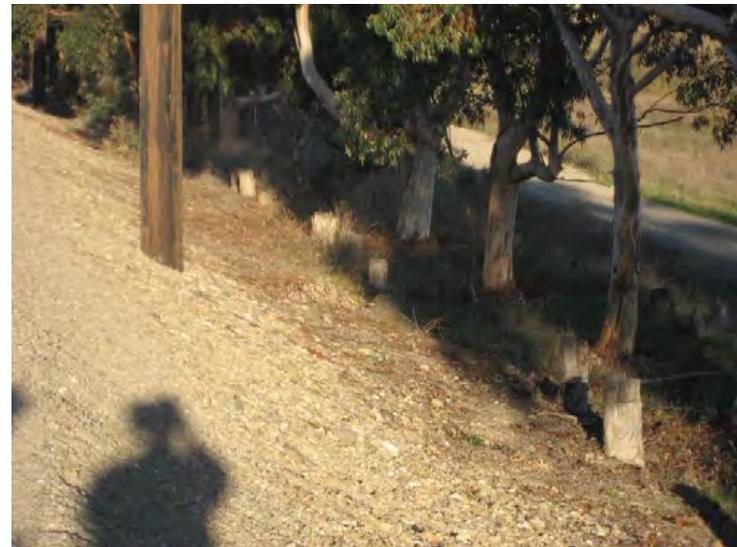
**Santa Clara River Levee, From Hwy 101 to Saticoy, (Photo No. M60) –
Trees, power poles & stumps within 15’ of toe, looking u/s (landward side)**

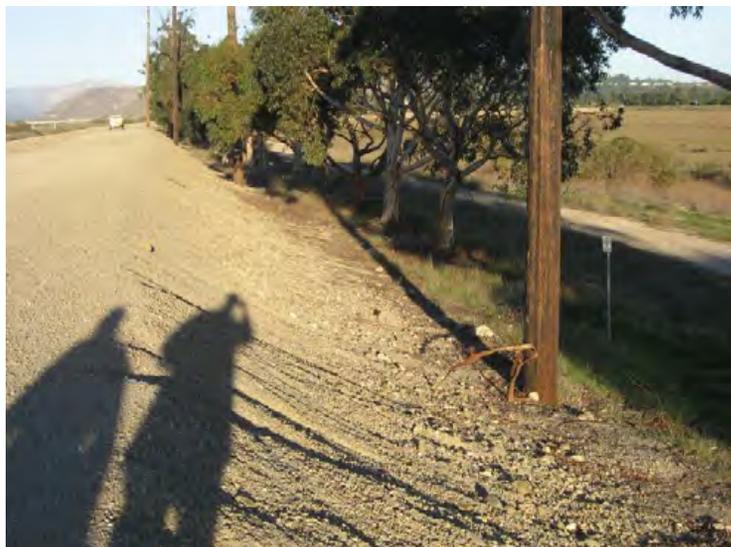
Santa Clara River Levee, From Hwy 101 to Saticoy, (Photo No. M61) –
Power poles on levee embankment, looking upstream (landward side)

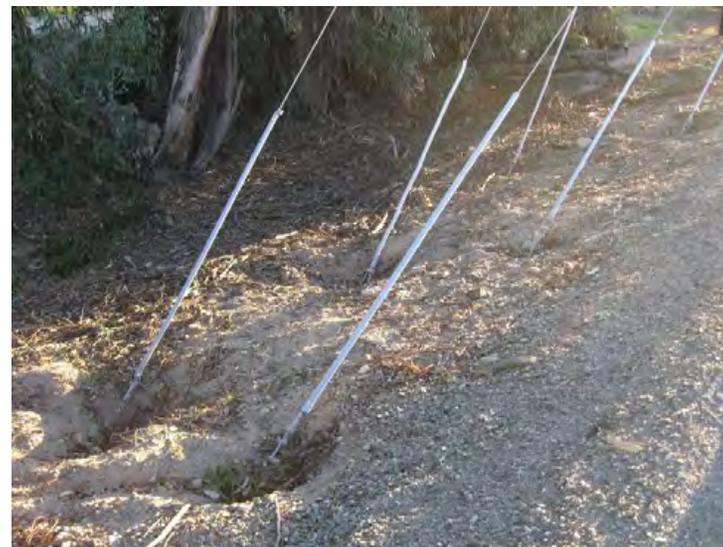
Santa Clara River Levee, From Hwy 101 to Saticoy, (Photo No. M63) –
Power poles guy wires anchored in levee bank, looking d/s (landward side)

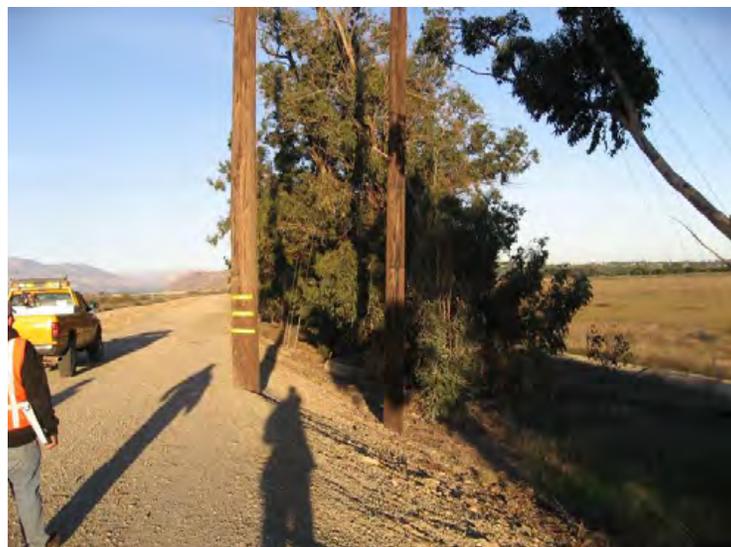
Santa Clara River Levee, From Hwy 101 to Saticoy, (Photo No. M62) –
Power poles on levee embankment, looking upstream (landward side)

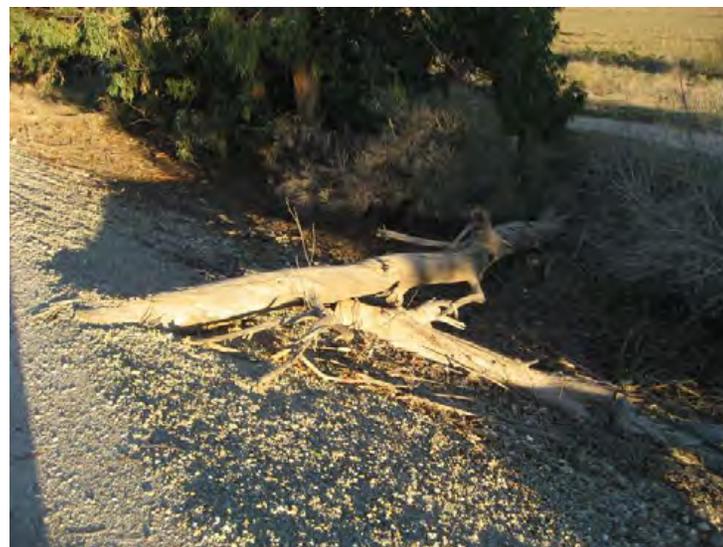
Santa Clara River Levee, From Hwy 101 to Saticoy, (Photo No. M64) –
Fallen trees and vegetation on levee bank, looking u/s (landward side)

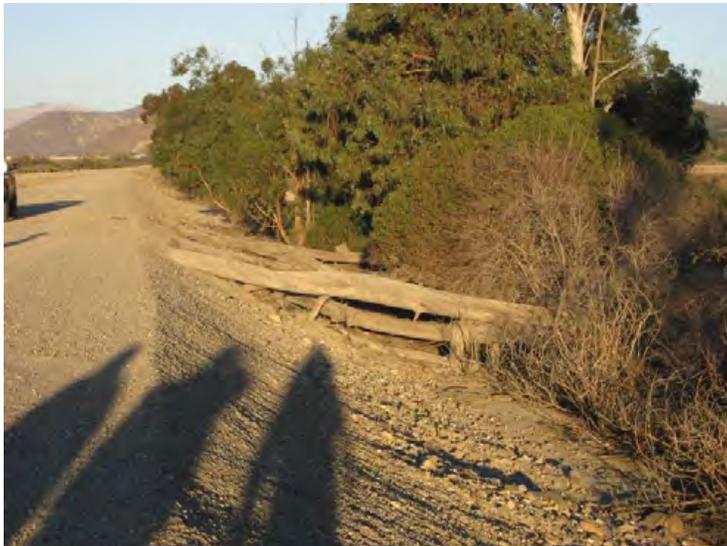
Santa Clara River Levee, From Hwy 101 to Saticoy, (Photo No. M65) –
Trees and fallen trees within 15' of levee toe, looking u/s (landward side)

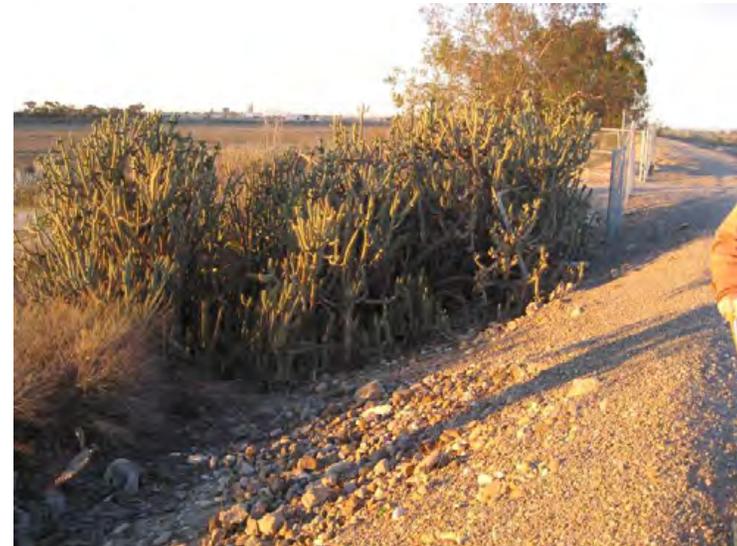
Santa Clara River Levee, From Hwy 101 to Saticoy, (Photo No. M67) –
Vegetation within 15-feet of levee toe, looking downstream (landward side)

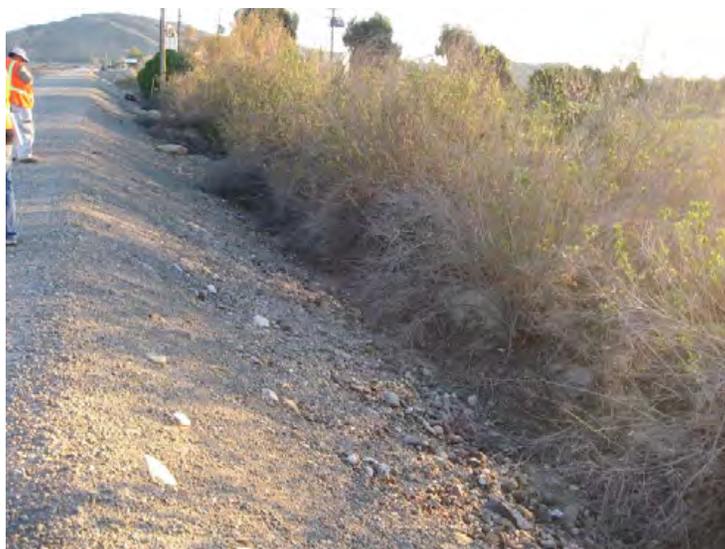
Santa Clara River Levee, From Hwy 101 to Saticoy, (Photo No. M69) –
Vegetation within 15-feet of levee toe, looking u/s (landward side)

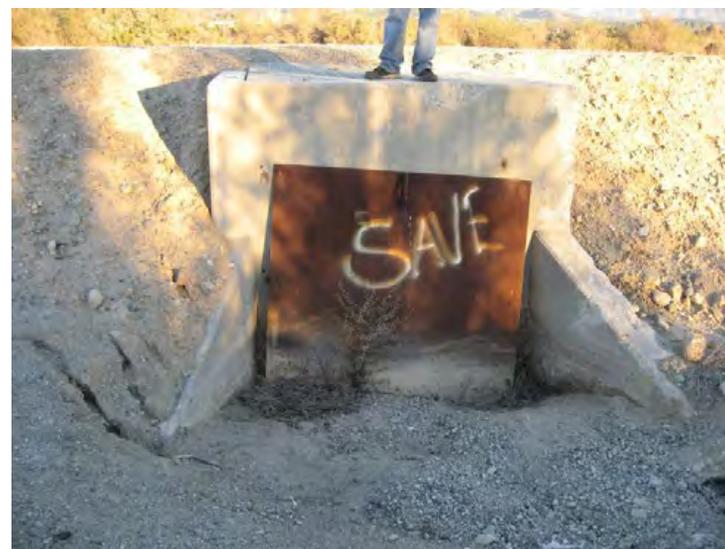
Santa Clara River Levee, From Hwy 101 to Saticoy, (Photo No. M71) –
Sediment & metal debris in Side Drain No. 3 inlet (landward side)

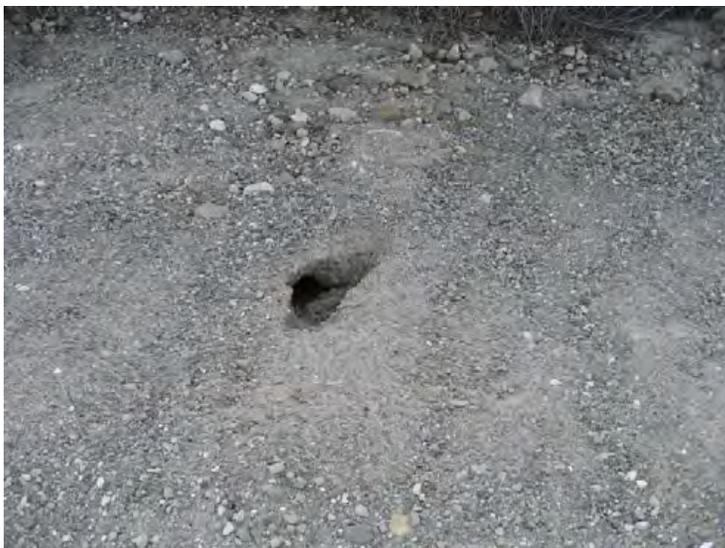
Santa Clara River Levee, From Hwy 101 to Saticoy, (Photo No. M70) –
Animal burrow on top of levee (landward side)

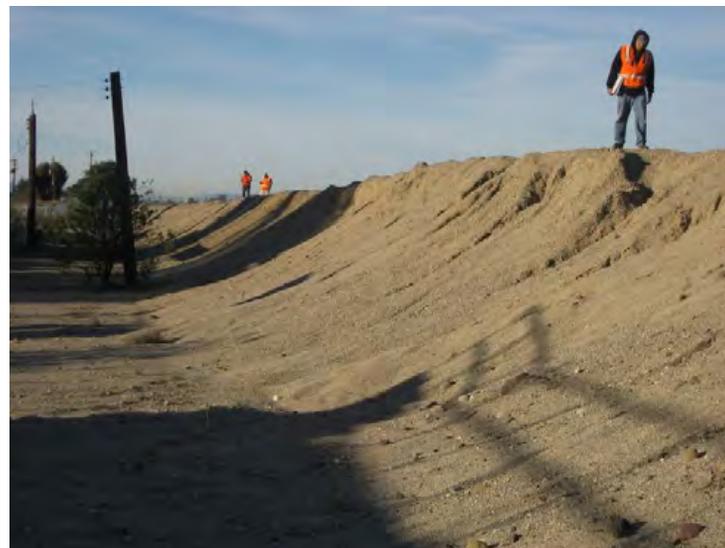
Santa Clara River Levee, From Hwy 101 to Saticoy, (Photo No. M72) –
Erosion on levee embankment, looking downstream (landward side)

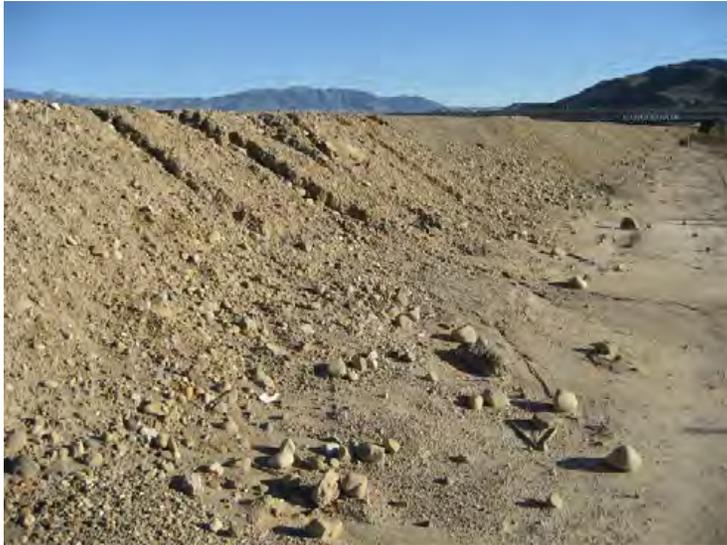
**Santa Clara River Levee, From Hwy 101 to Saticoy, (Photo No. M73) –
Erosion on levee embankment, looking upstream (landward side)**

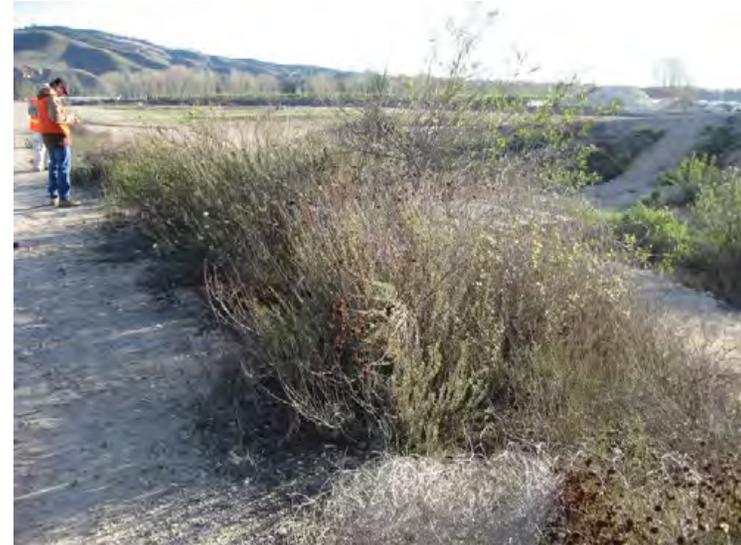
**Santa Clara River Levee, From Hwy 101 to Saticoy, (Photo No. M75) –
Vegetation within 15-feet of levee toe, looking downstream (landward side)**

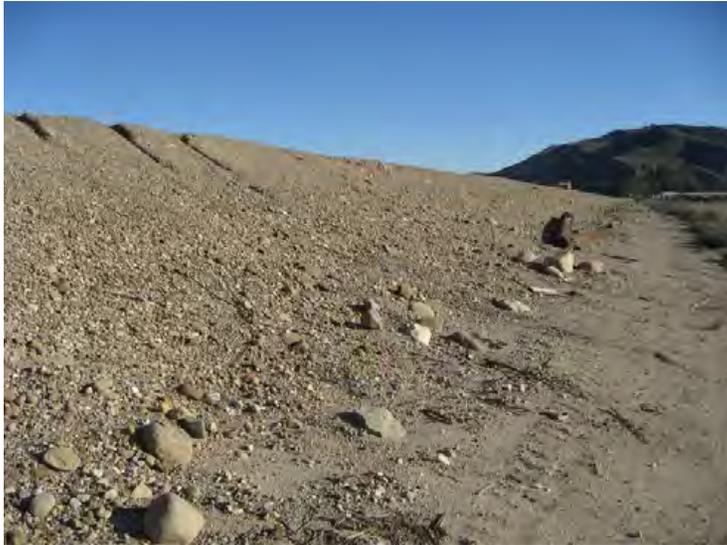
Santa Clara River Levee, From Hwy 101 to Saticoy, (Photo No. M77) –
Erosion at top of levee with debris at toe, looking d/s (landward side)

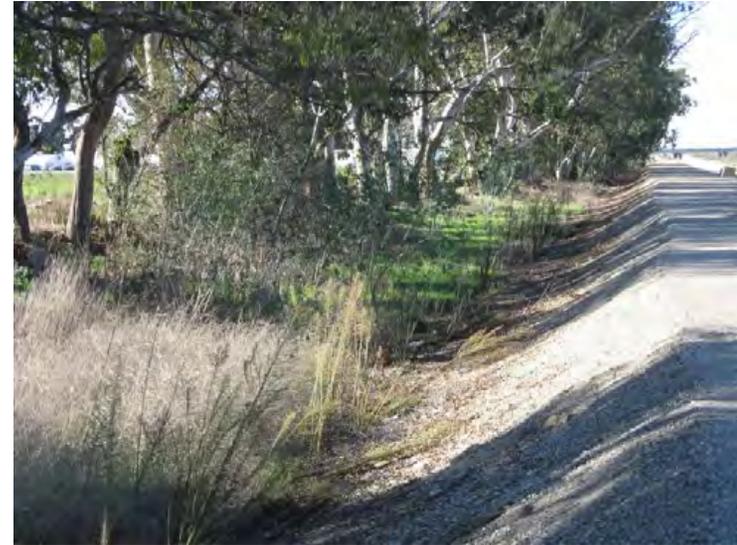
Santa Clara River Levee, From Hwy 101 to Saticoy, (Photo No. M79) –
Trees within 15-feet of levee toe, looking downstream (landward side)

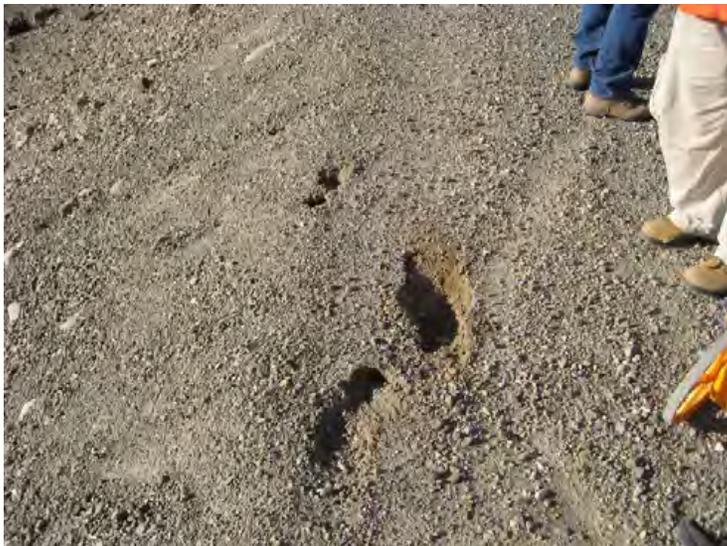
Santa Clara River Levee, From Hwy 101 to Saticoy, (Photo No. M78) –
Animal burrows at top of levee (landward side)

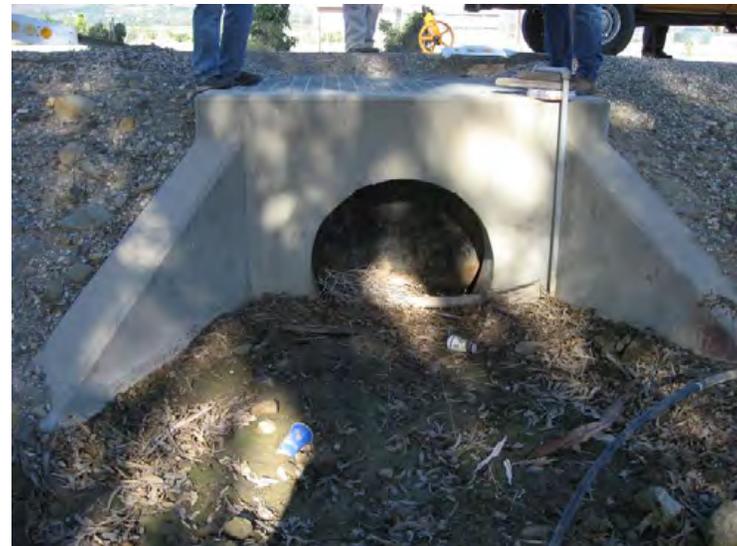
Santa Clara River Levee, From Hwy 101 to Saticoy, (Photo No. M80) –
Sediment and debris in Side Drain No.1, 42” RCP inlet (landward side)

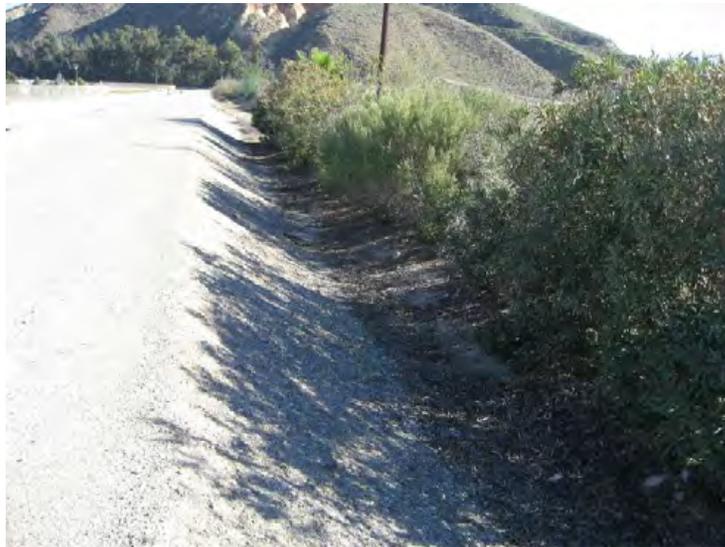
**Santa Clara River Levee, From Hwy 101 to Saticoy, (Photo No. M81) –
Vegetation within 15-feet of levee toe, looking upstream (landward side)**

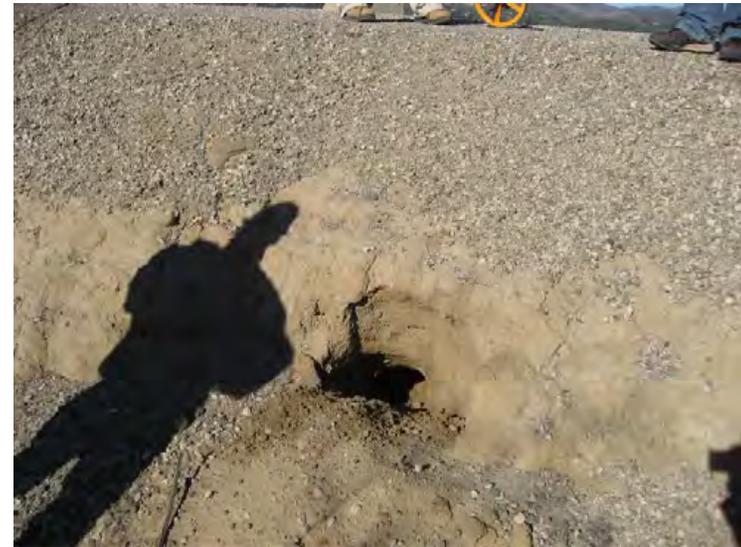
**Santa Clara River Levee, From Hwy 101 to Saticoy, (Photo No. M83) –
Animal burrows at levee toe (landward side)**

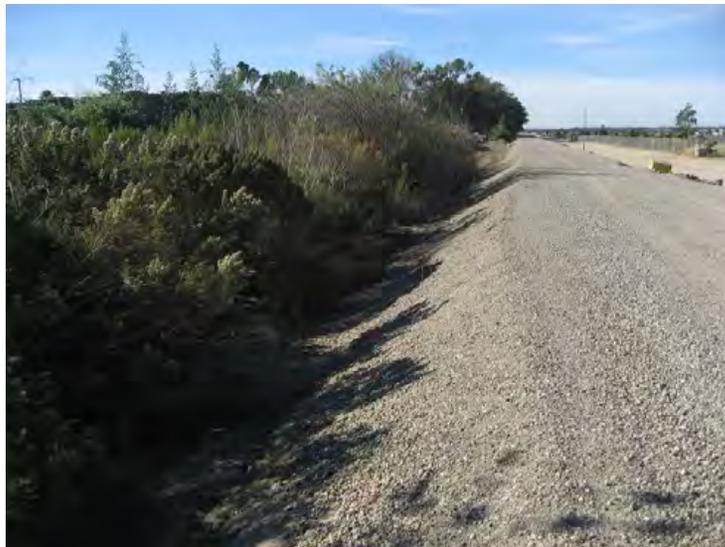
**Santa Clara River Levee, From Hwy 101 to Saticoy, (Photo No. M82) –
Vegetation within 15-feet of levee toe, looking downstream (landward side)**

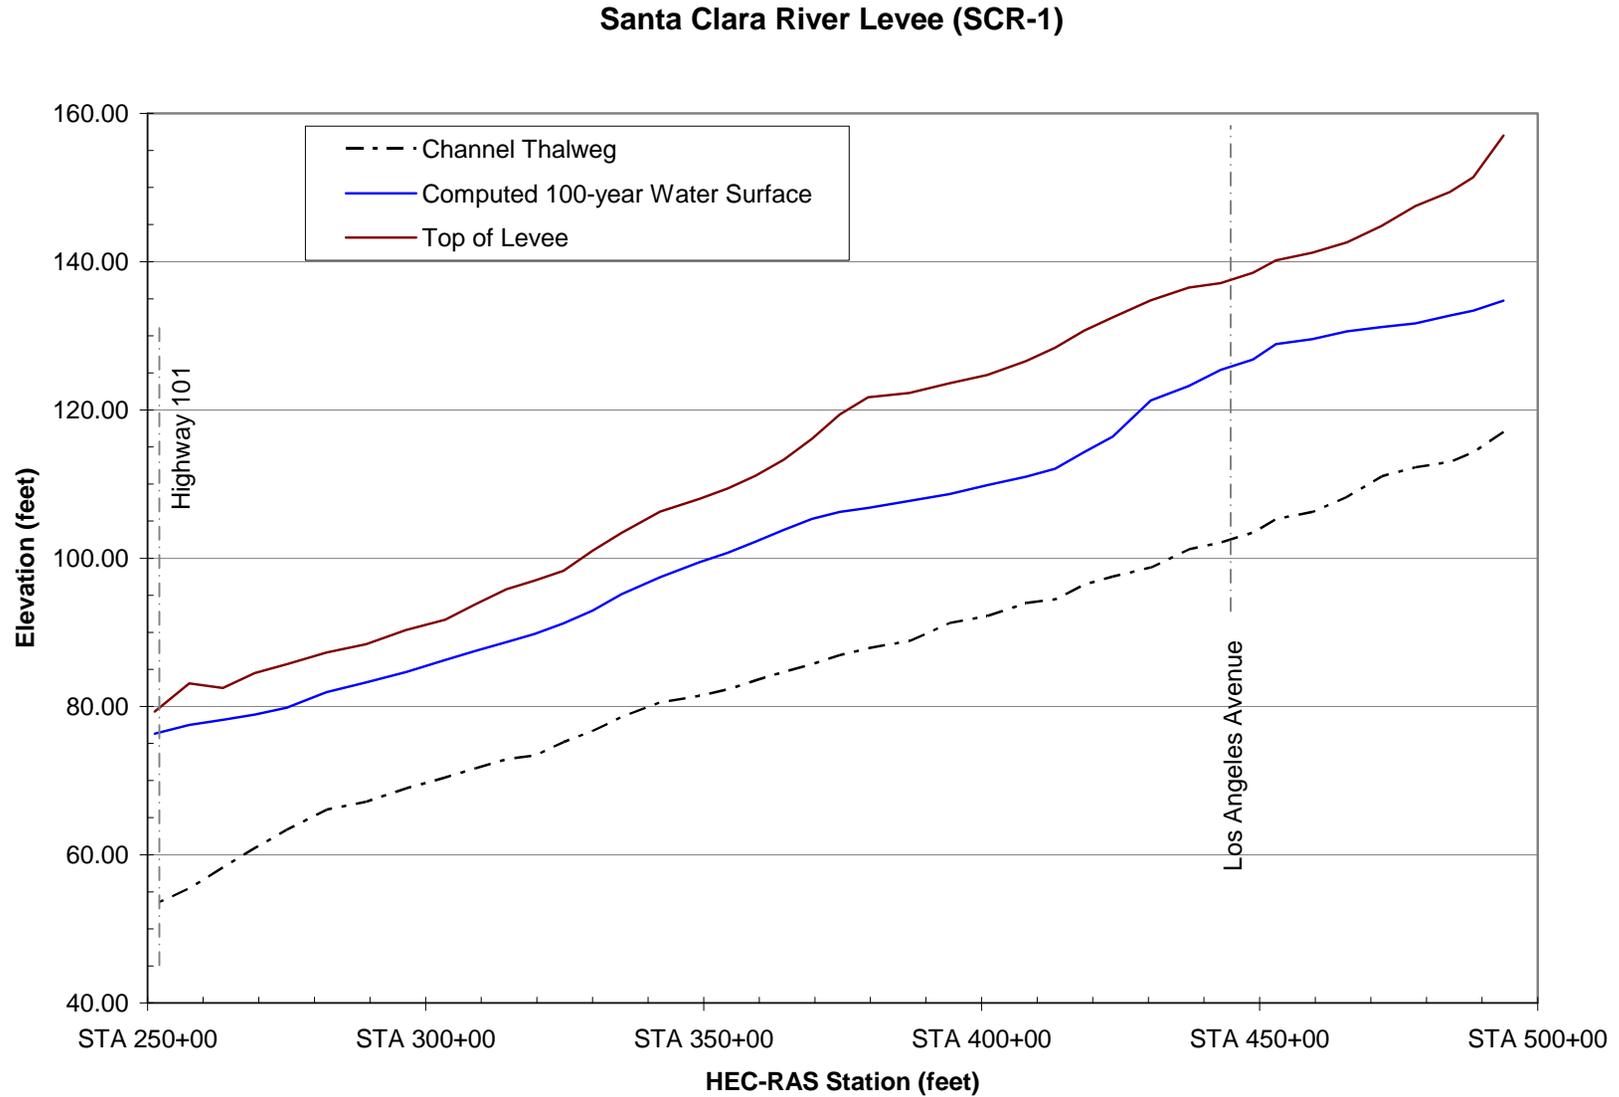
Figure 4 – Computed 100-year Water Surface Profile along SCR-1 Levee

For the SCR-1 Levee, water surface profiles were computed using the Levee Certification HEC-RAS model, described above. Table 4 shows computed channel hydraulics of the 100-year peak discharge based on the subcritical flow regime analysis. Figure 4 depicts the profiles of the top of levee, channel thalweg, and computed 100-year flood water surface along the levee. HEC-RAS computer printouts are presented in Attachment B.

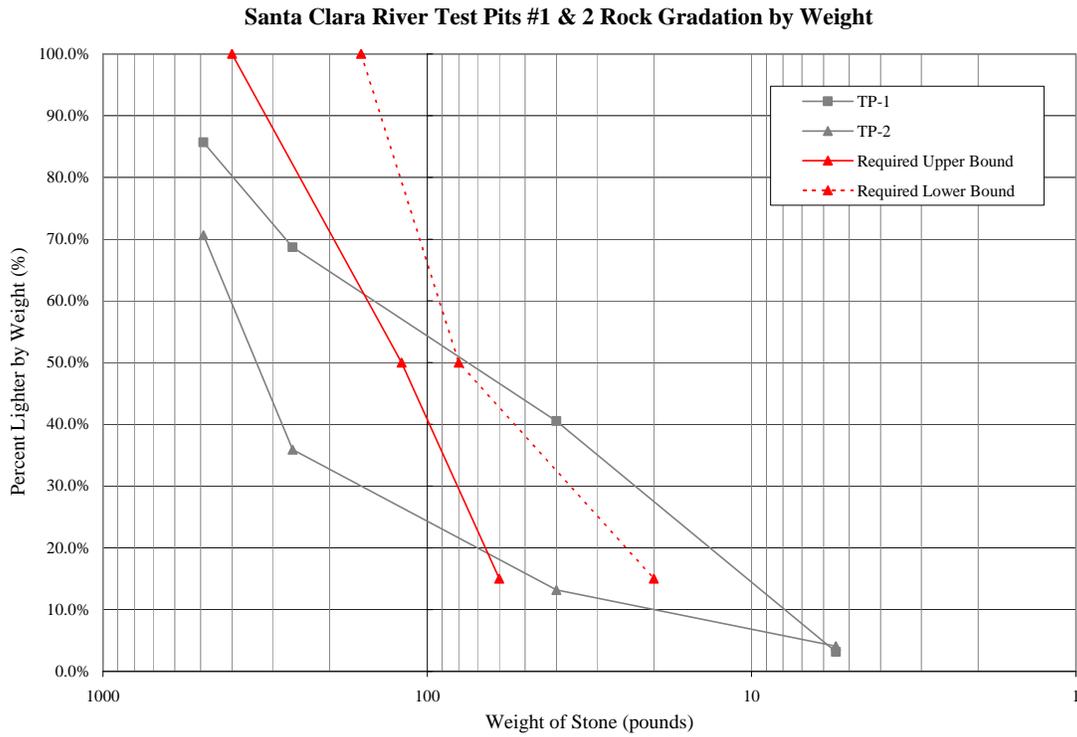
Figure 10 –Rock Revetment Gradation near Test Pits # 1 & 2

The estimated gradation of the rock revetment observed in the field was plotted alongside the gradation calculated by the CHANLPRO program for the two sections (HEC-RAS Station 354+30 and Station 407+99). Station 354+30 is closest to Test Pits #1 and #2. In general the large revetment rock, D_{60} and higher, sampled in the field at Test Pits #1 and #2, is heavier than the computed rock weights for the hydraulic conditions at Station 354+30. For rock sizes from less than the D_{60} to about the D_{50} Test Pit #1 is slightly larger than the lower bound of the calculated rock size envelope. For the D_{50} to the D_{40} Test Pit #1 material is slightly smaller than the lower bound of the calculated required rock size. For sizes below the D_{40} , Test Pit # 1 is about 50% smaller than the rock required by the lower bound. In contrast, Test Pit #2 sizes remain larger than the upper bound of the required rock size from the D_{100} down to about the D_{20} , where it is equal to the upper bound. The gradation of Test Pit #2 is heavier than the required computed rock size however it is poorly distributed and does not fit within the computed gradation envelope as shown in Figure 10.

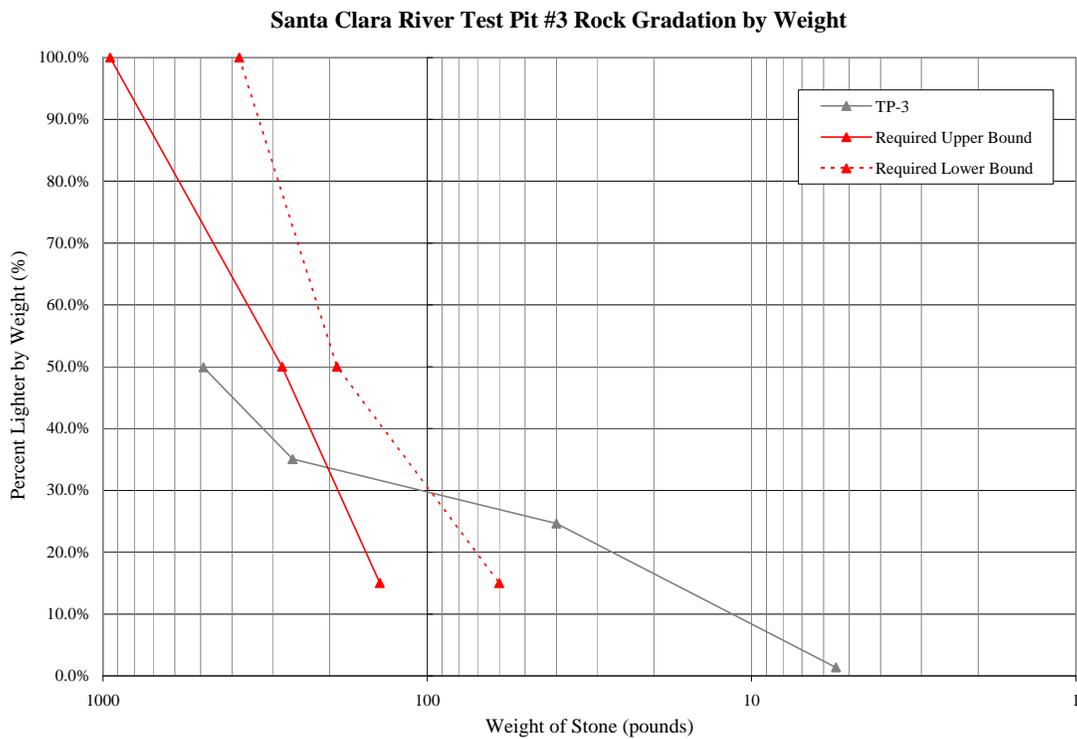
Figure 11 – Rock Revetment Gradation near Test Pit # 3

The hydraulics and the associated required rock revetment sizes near Test Pit #3 are best represented by those calculated for station 407+99. The gradation of Test Pit #3 is heavier than the required computed rock size; however, it is poorly distributed and does not fit within the computed gradation envelope as shown on Figure 11 of Appendix D3.

The hydraulics and the associated required rock revetment sizes near Test Pit #3 are best represented by those calculated for Station 407+99. The gradation of Test Pit #3 is heavier than the required computed rock size however it is poorly distributed and does not fit within the computed gradation envelope as shown on Figure 11.

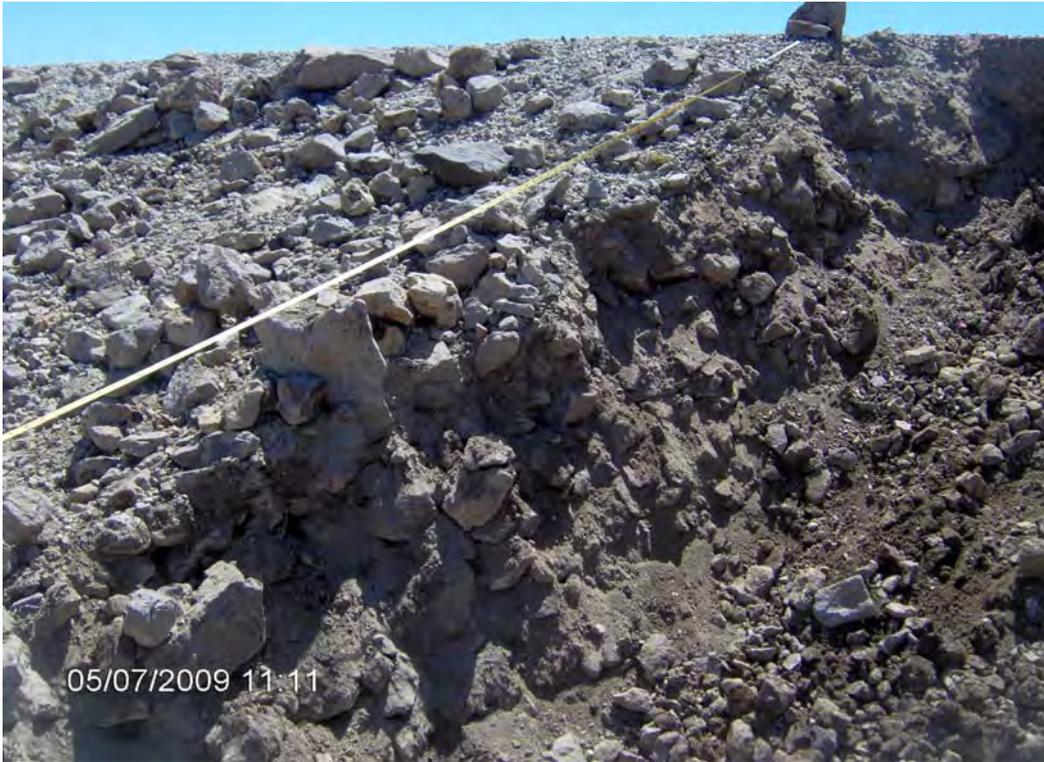
Photo 1: Test pit SCR-1-TP1. Looking along upstream wall of trench.

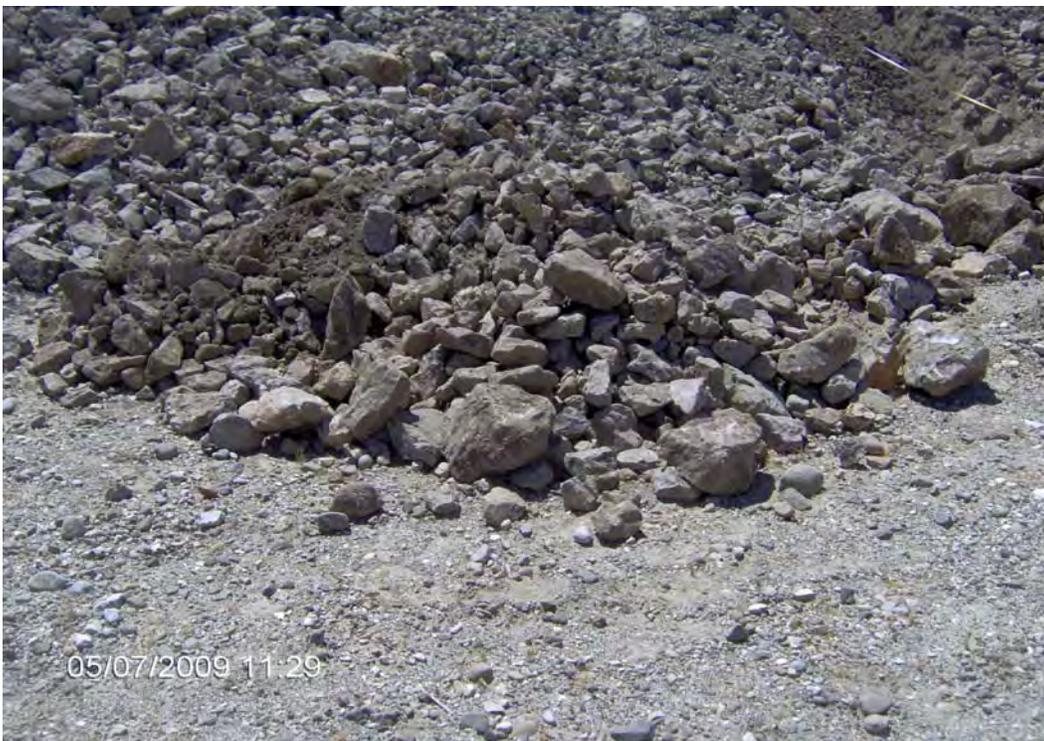
Photo 2: Test pit SCR-1-TP1. Stockpile of material.

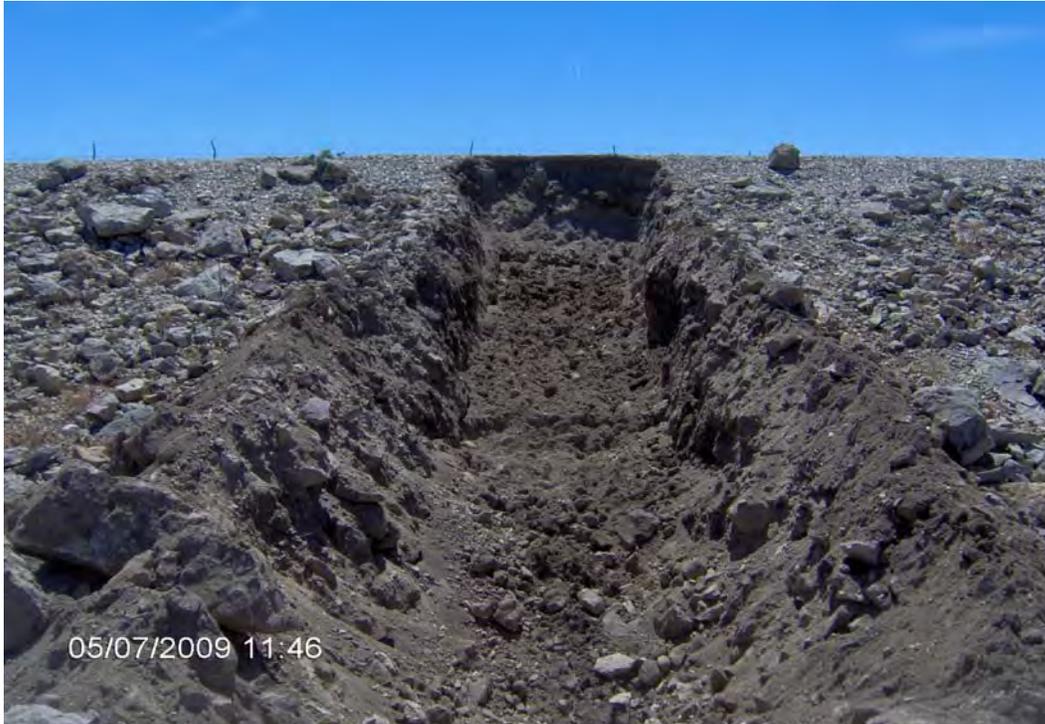
Photo 3: Test pit SCR-1-TP2. Looking perpendicular to levee. Note fine material.

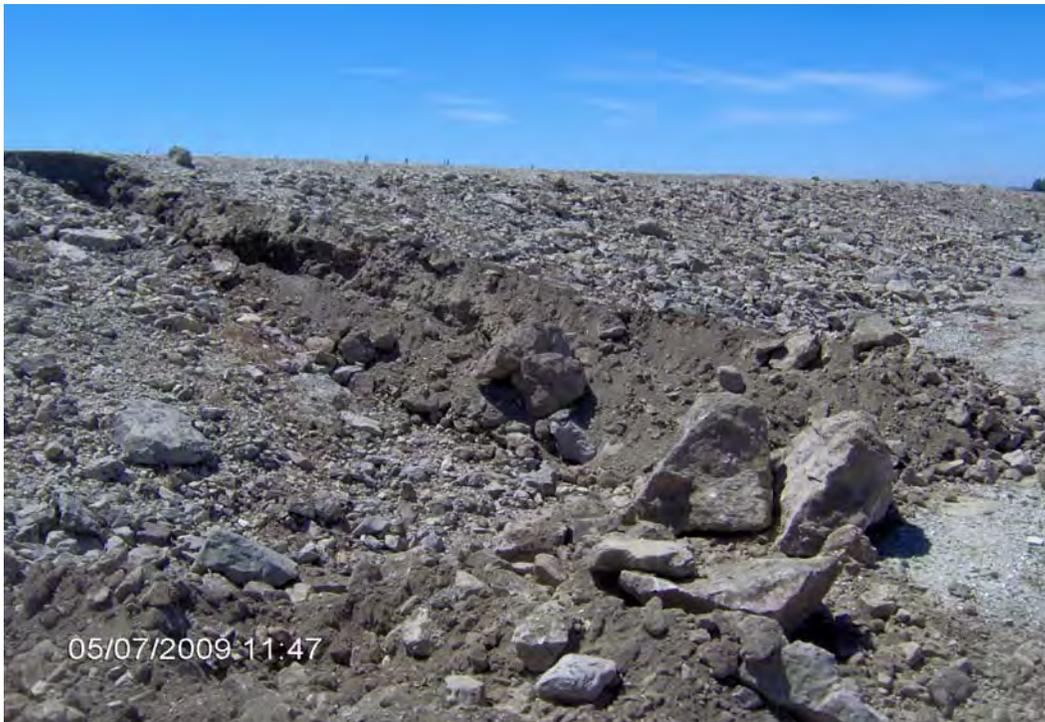
Photo 4: Test pit SCR-1-TP2. Looking downstream. Note fine material in trench and larger material at toe.

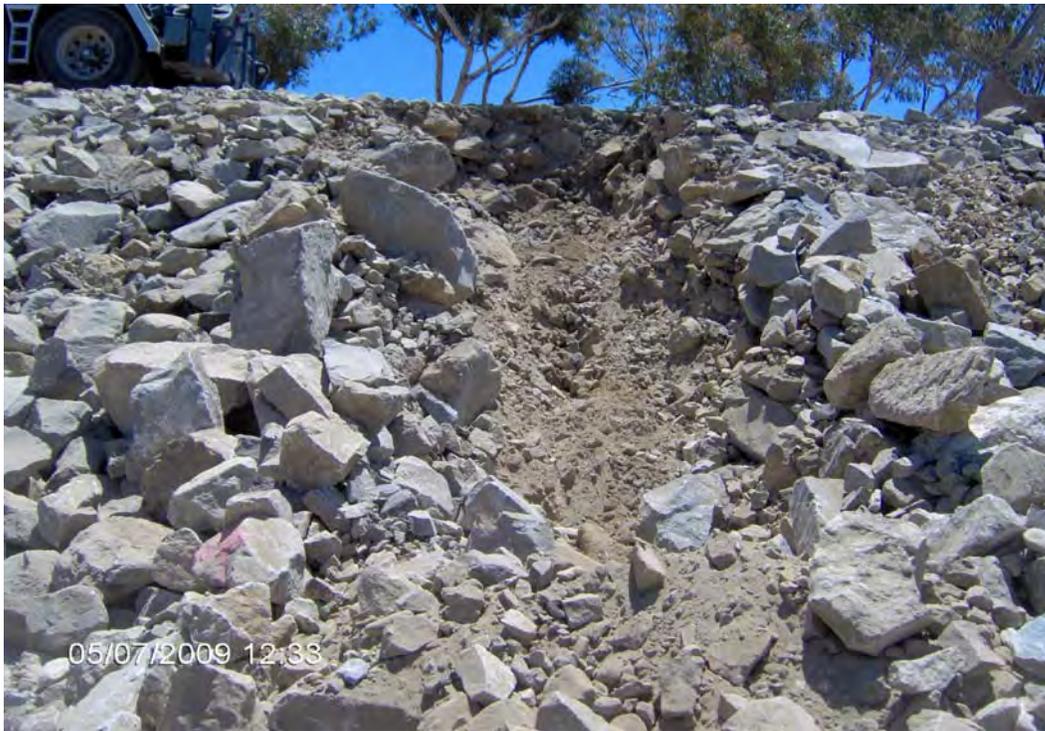
Photo 5: Test pit SCR-1-TP3. Looking perpendicular to levee. Note coarser revetment.

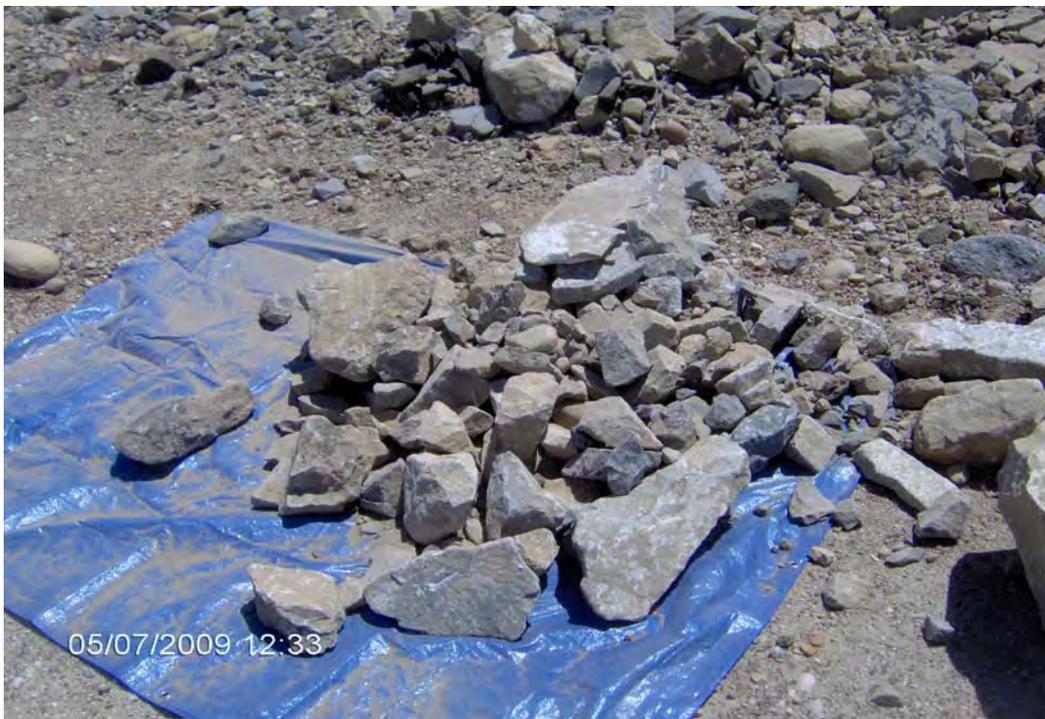
Photo 6: Test pit SCR-1-TP3. Sample pile.
