FEMA PAL Response Report

SANTA CLARA RIVER LEVEE (SCR-1)

HIGHWAY 101 TO SATICOY

FEMA ID No. 18

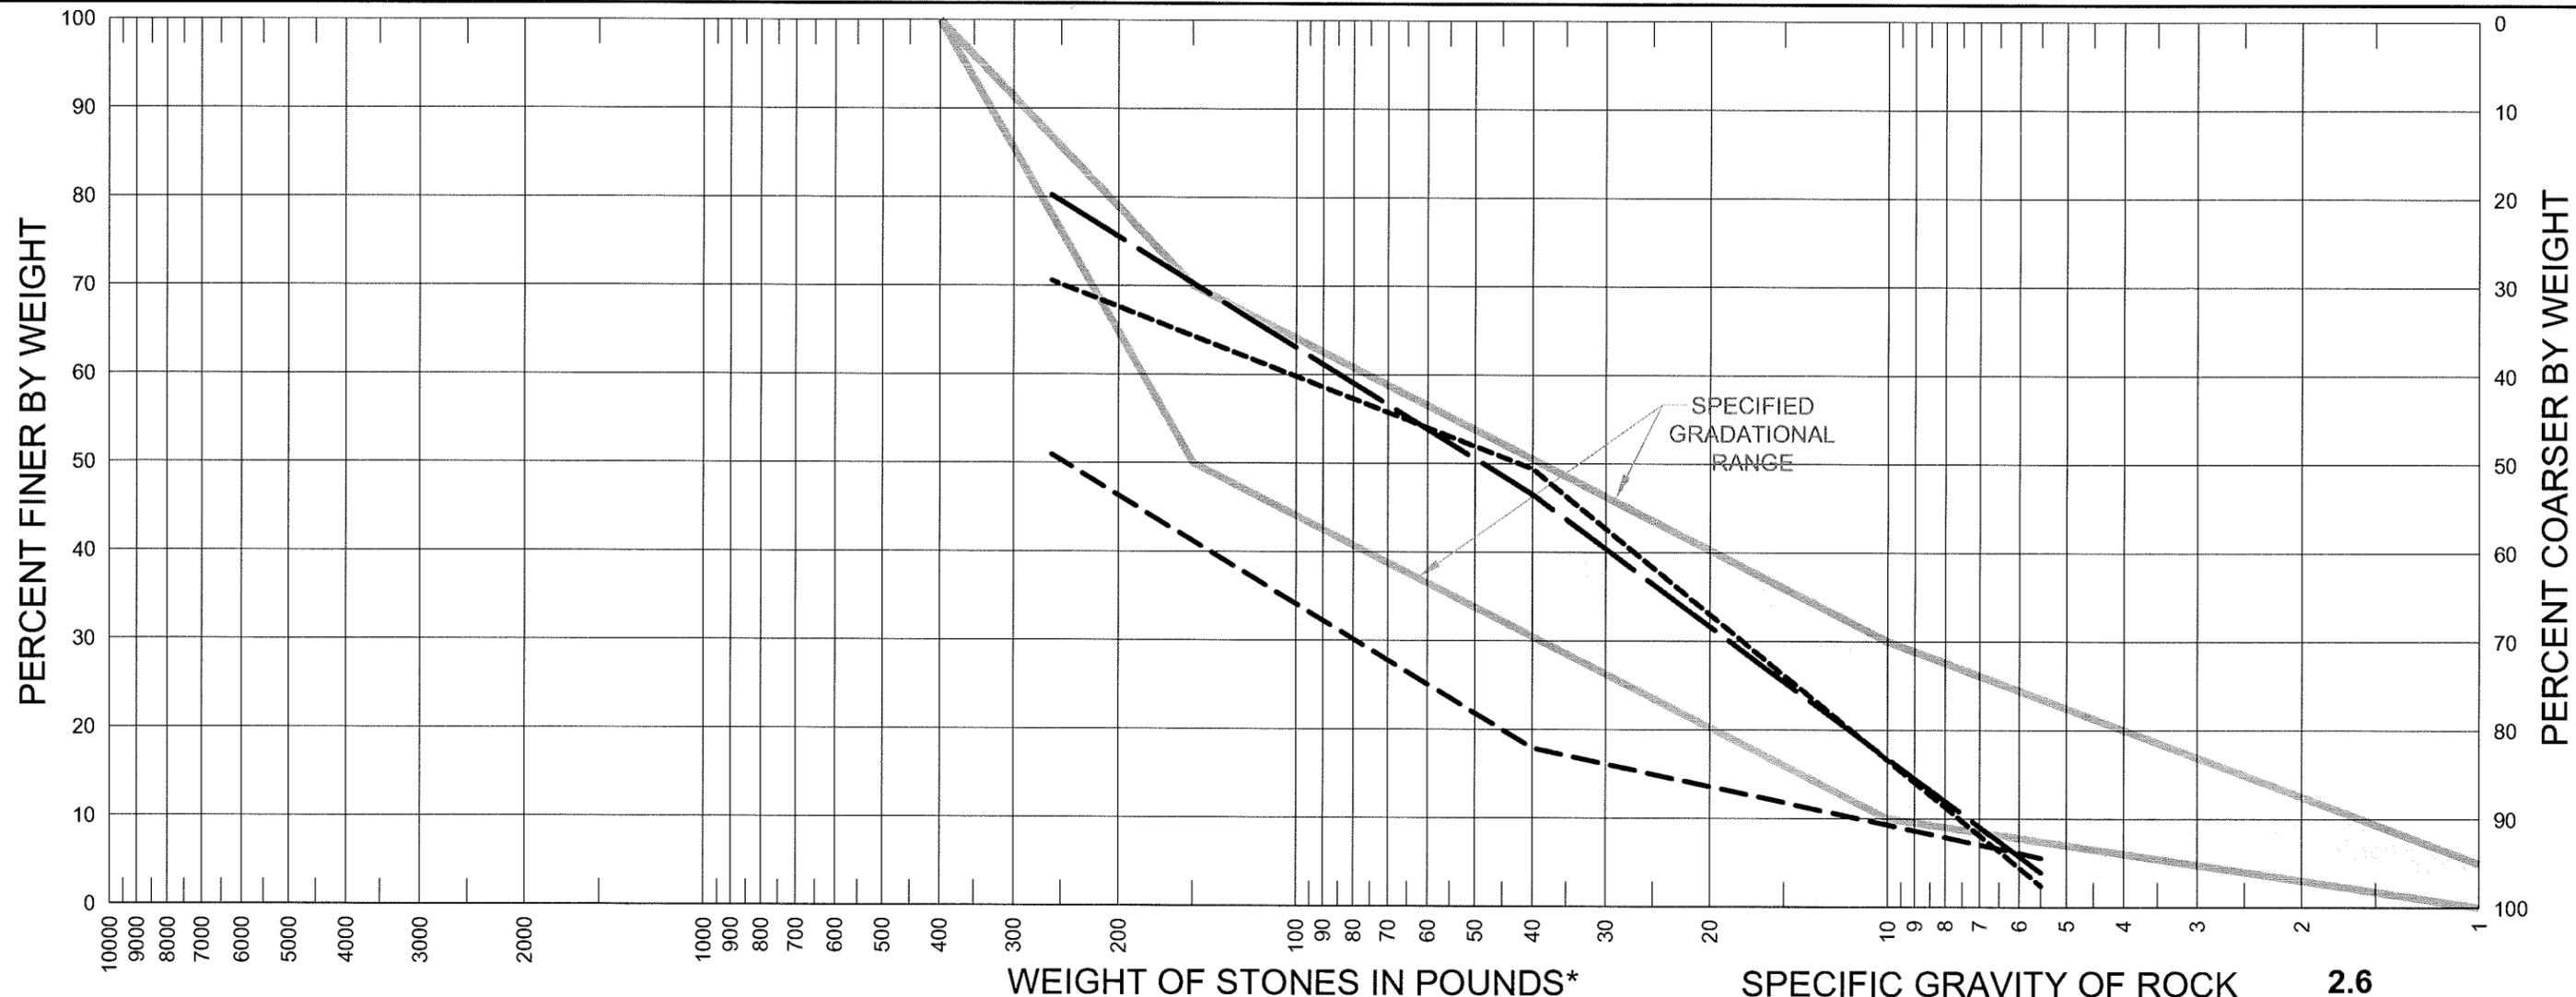
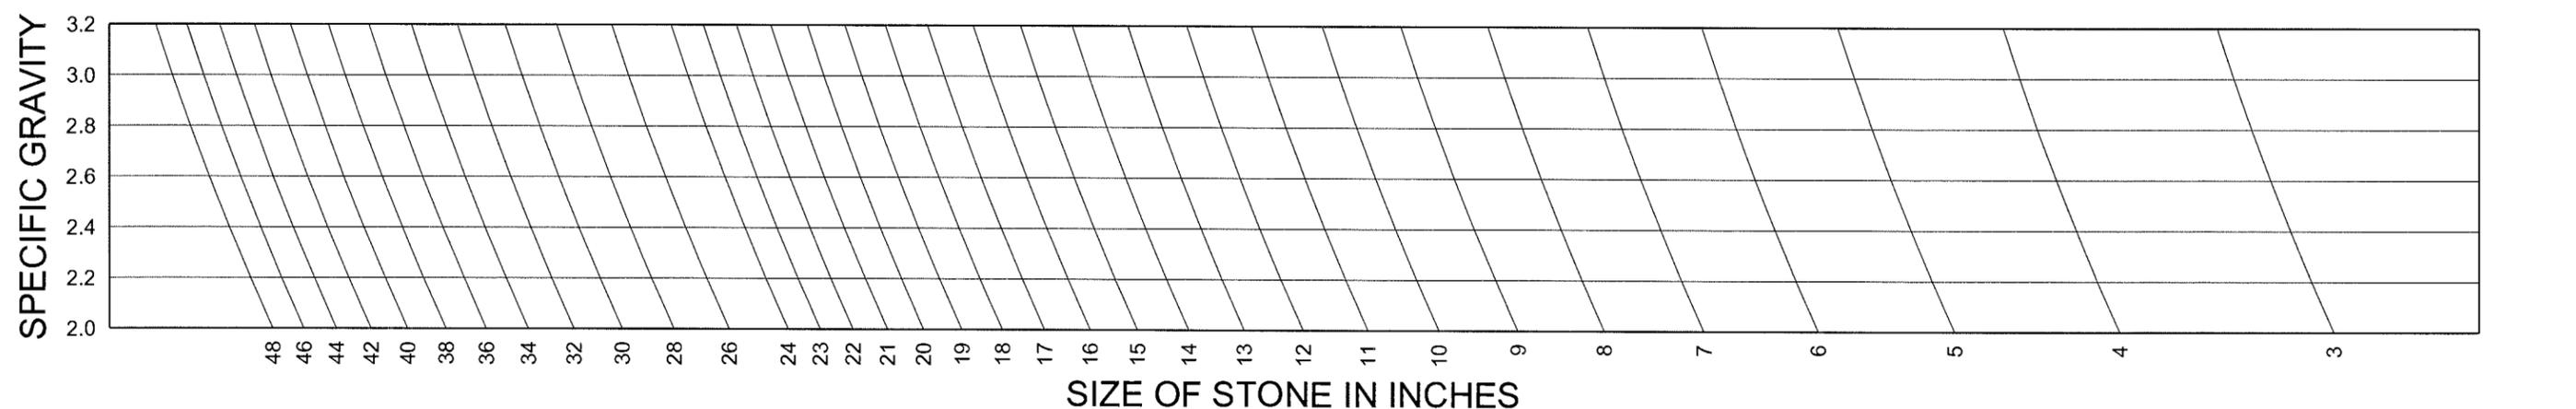
- TEST PIT SCR-1-TP1 (PLATE V)
- TEST PIT SCR-1-TP2 (PLATE VI)
- - - - -** TEST PIT SCR-1-TP3 (PLATE VII)
